CORROSION AND CRACKING IN AIR INJECTION PIPE

Prepared by: James Buchanan, Associate

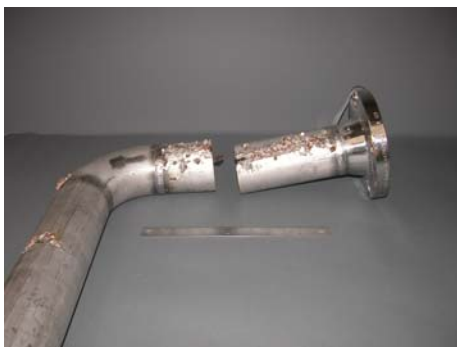
Figure 1

Visual examination of the sample revealed several areas of cracking and corrosion on the external surface (Figure 1). Markings on the flange indicated that it was 316 stainless steel, while markings on the elbow revealed that it was 304 stainless steel. The visual examination also indicated that the damage occurred in areas where there were signs of surface deformation and denting on the external surface of the pipe (Figure 2). Additionally, there was evidence of heavy dark brown corrosion deposits in the cracks and had expanded, causing the pipe material to delaminate.

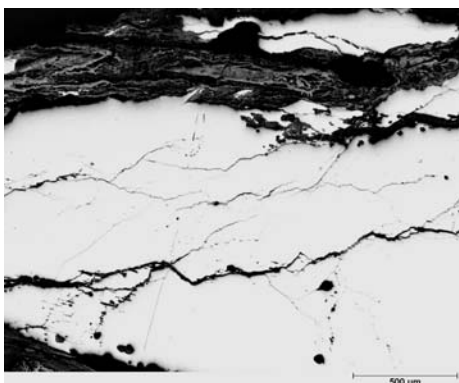
Figure 3

Metallurgical examination revealed widespread cracking at the location examined. The cracking appeared to have initiated on the pipe's external surface where the mechanical damage had occurred, and propagated somewhat parallel to the surface of the pipe with many of the cracks spreading completely through the wall of the pipe (Figure 3). Cracks were also found in the flange particularly near the bolt holes.

The impact damage resulted in deformation of the pipe surface and caused tensile stresses in the pipe wall. These high local stresses resulted in CSCC which spread through the wall of the pipe. In addition to CSCC, the piping also suffered exfoliation type corrosion - a result of the expansion of the corrosion products that formed inside of the cracks.

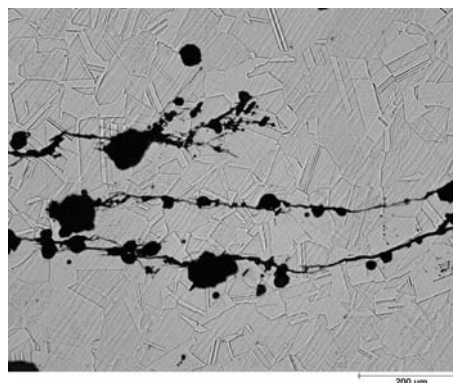
Figure 4

Metallurgical examination revealed that the majority of the cracks observed exhibited a branched, transgranular morphology typical of chloride stress corrosion cracking (CSCC), while the unbranched, transgranular nature of a few of the cracks suggests that they were initiated by fatigue (Figure 4).

Numerous areas of corrosion and cracking were found on the external surface of the pipe. Although it was not possible to determine with certainty whether the cracks were initiated by CSCC or fatigue, the existence of both branched and unbranched cracks suggests that the cracks resulted from both mechanisms. The cracks were caused by tensile stress produced by the pipe repeatedly striking the baffle inside the tank. The increased pipe movement was the result of the retaining bracket failure, which is designed to prevent such motion.
