Evaluation of the W. A. Parish Cold Reheat Piping Failure

Case study prepared by Chris Alexander, Senior Associate/Staff Consultant • chris.alexander@stress.com (e-mail)

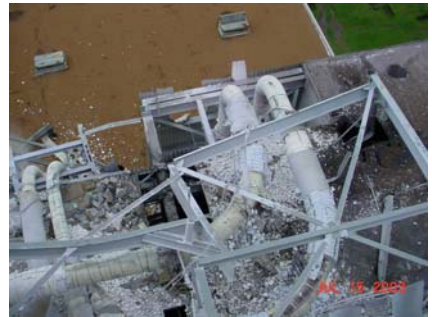
On July 15th the Cold Reheat Line of the Texas Genco's W. A. Parish Plant experienced a catastrophic failure that included significant collateral damage (no lives were lost or personal injuries occurred). After rebuilding the piping system Texas Genco and Reliant Resources contacted Stress Engineering Services to assist in a Root Cause Analysis (RCA). Concerns were raised about a damaged attemperator that could have contributed to the longitudinal seam failure. A Reliant Resources report indicated that the failure initiated from a toe crack on the non-ground longitudinal weld on the inside surface of the pipe.

Failure of Cold Reheat Line

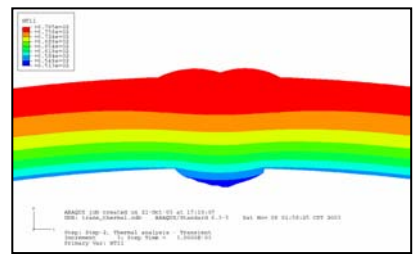
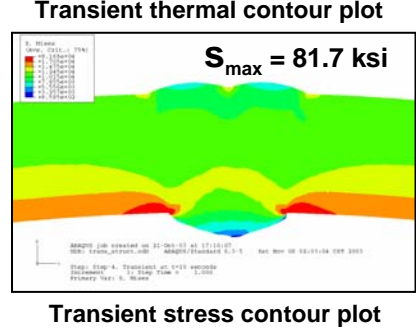
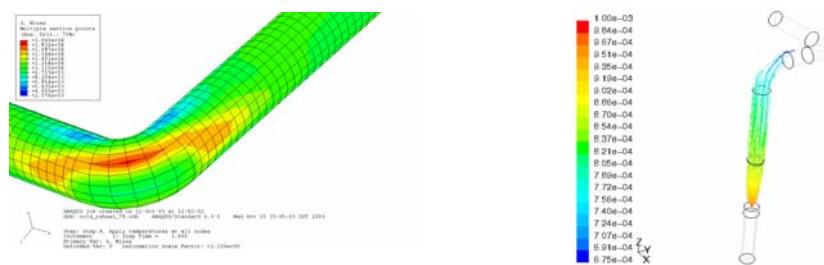
TRANSIENT ANALYSIS

10 seconds after quench
