PLANT AIR COMPRESSOR SYSTEM PINION

Prepared by: James Buchanan, Associate

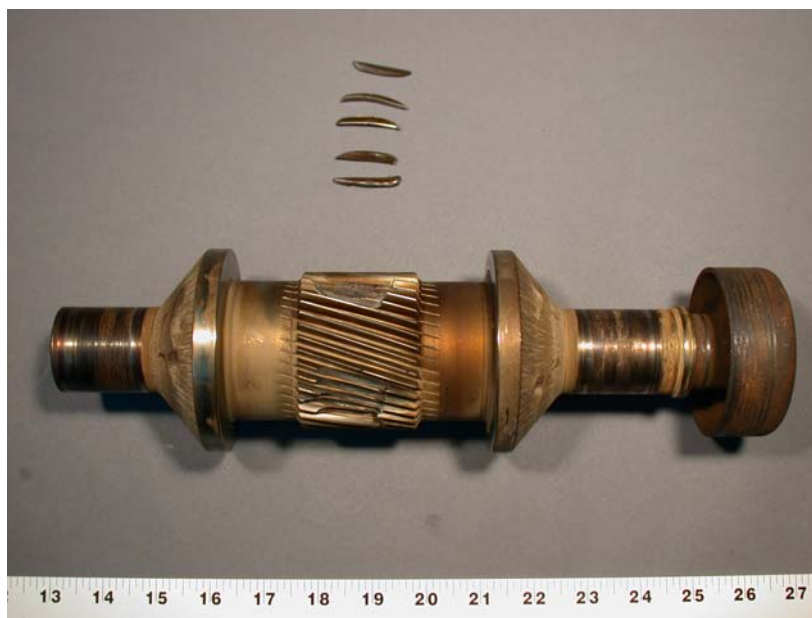
A reliable supply of compressed air is vital in many industries. The pinion pictured below was part of a gear-reduction system used to drive a plant air compressor. Failure of the teeth in this and a replacement pinion occurred in the same machine within a short time-span, leading to concern regarding the overall reliability of the system.

Examination of the fracture surfaces caused by the tooth failures indicated that the teeth all failed by tooth bending fatigue, which is one of the most common gear tooth failure modes.

The pinion bearing surface damage observed suggested that the lubricity of the bearing surfaces had decreased, probably as a result of water that was detected in the lubrication system. This reduction in lubricity is believed to have caused increased loading on the pinion teeth leading to the initial tooth failure. Once the first tooth failed, the load on the next tooth in the direction of rotation would have increased causing it to fail and so on. It was recommended that efforts were made to ensure the system remained free of water.
