LEAKING SHRIMP TRAWLER

Prepared by: Lori Hasselbring, Ph.D, Staff Consultant

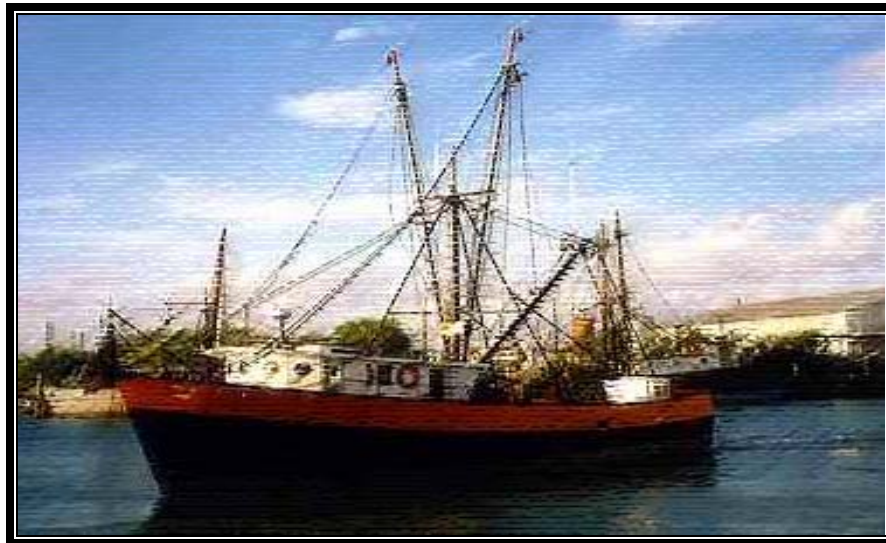
Chemical analysis revealed that the epoxy resin and hardener labels were switched so that incorrect amounts were used. Various ratios of resin-to-hardener were prepared in the laboratory and tested by differential scanning calorimetry to determine the correct ratio; however, the epoxy never cured.

It was concluded that quality control problems in the epoxy manufacturing process were responsible for the leaking shrimp trawler.
