Piping Corrosion Assessment: A Case Study

SES can help determine the cause, evaluate the damage and predict future performance

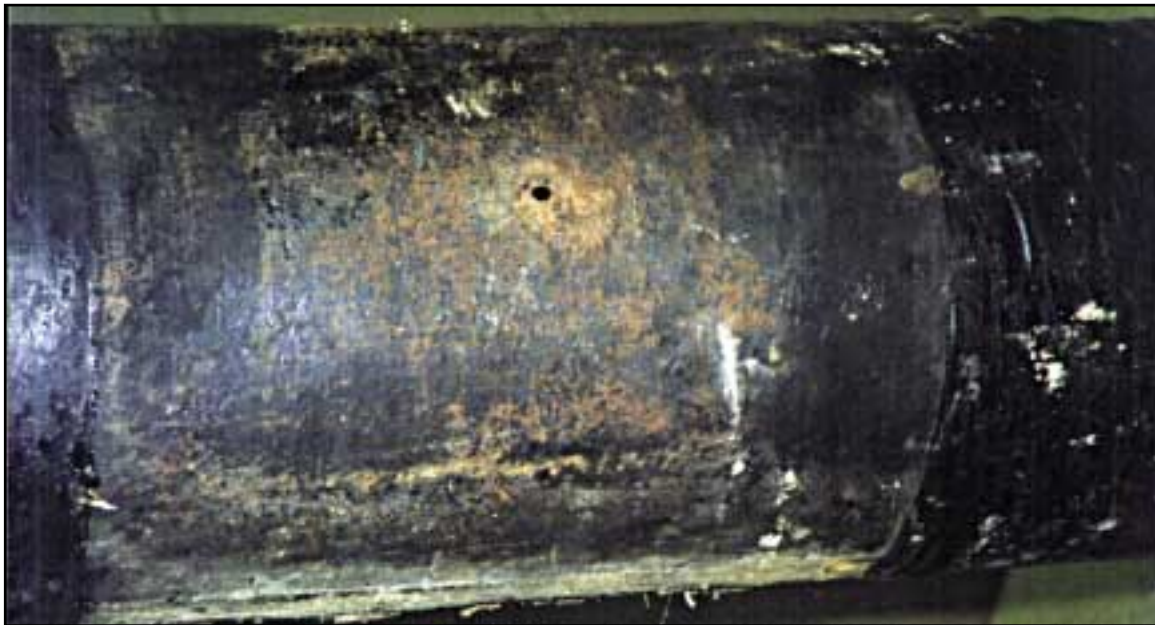
One of a family of pits originating along the pipe interior that penetrated the pipe wall.

SES engineers collected scale and corrosion products from the inside of the pipe and analyzed them using x-ray diffraction and fluorescence. The results identified active corrosion processes and corrodents including general weight loss and pitting corrosion due to carbon dioxide gas.

After cleaning the corrosion products from the internal pits, pit diameters and depths were measured. A subsequent statistical analysis indicated that the existing pit distribution could result in a pit deep enough to penetrate the pipe wall every 1.4 miles. Based on this information, SES recommended that the pipe line be shut down until it could be inspected and its condition verified.

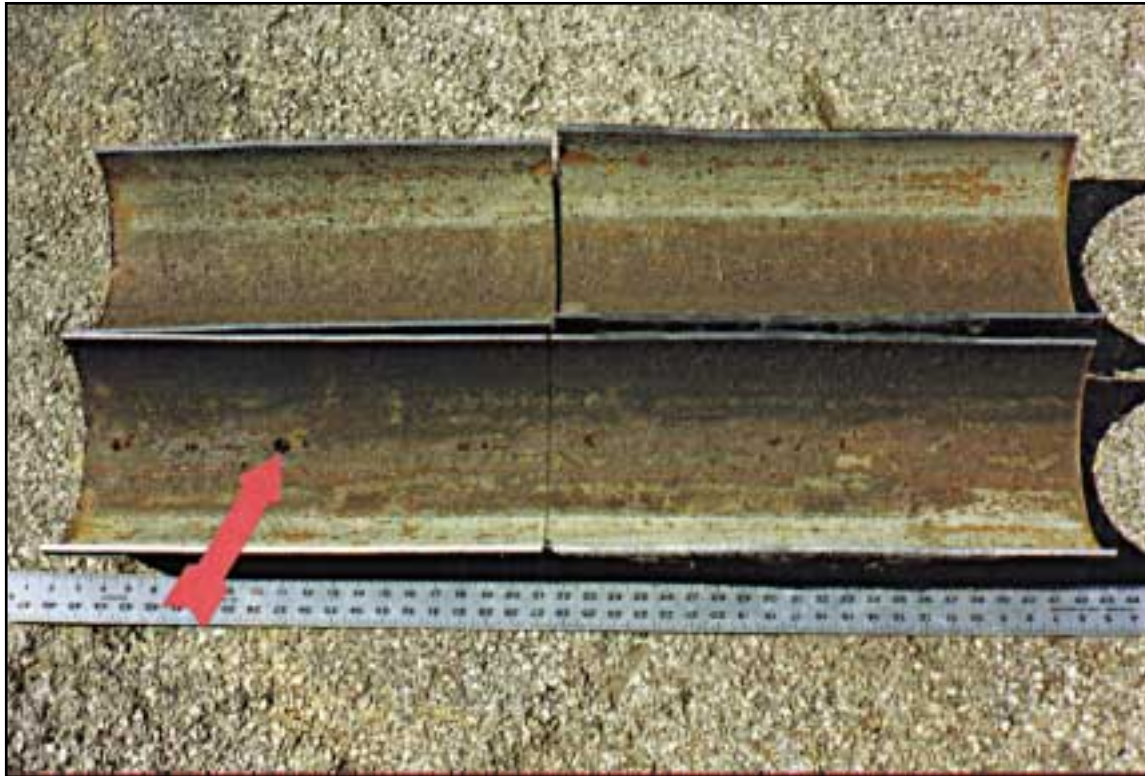
Cross section of pipe showing location of pit

The next step was to perform a metallurgical analysis of the pipe. These studies indicated that corrosion was not the result of manufacturing processes or defects.
