Fatigue performance characterization of a manufacturing seam defect in high-frequency electric-resistance-welded pipe

by Travis Schott¹, Dr Chantz Denowh², and Chris Alexander²

Pipeline Pigging and Integrity Management Conference

1-2 March, 2017

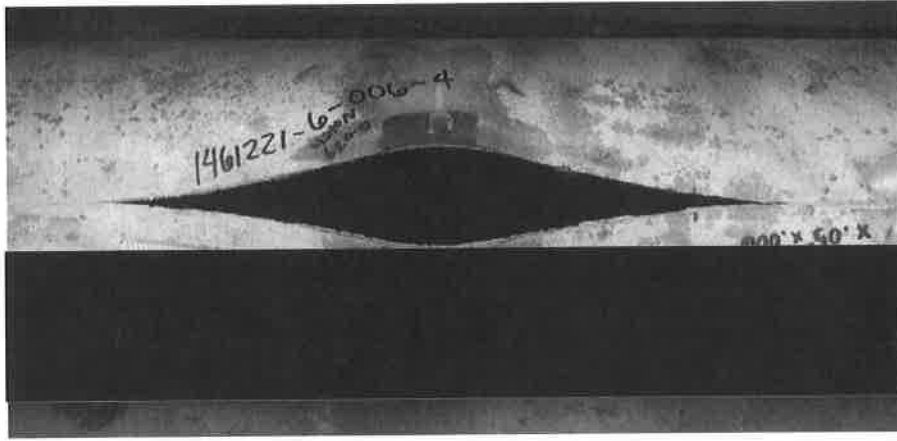
Sample 4 burst at a pressure of 132% SMYS at the 25% notch location as shown in Figure 4-7. Strains in the base pipe and HF ERW seam remained stable during two five minute holds at 72% and 100% SMYS. The two (2) base pipe strain gages located at 90° both reached 5,500 microstrain (0.55% strain) at failure. The HF ERW seam strains at failure were lower the base pipe at 4,000 and 4,600 microstrain.

Figure 4-7: Sample 4 (10% and 25% notch) failure surface at the 25% notch in the HF ERW seam.

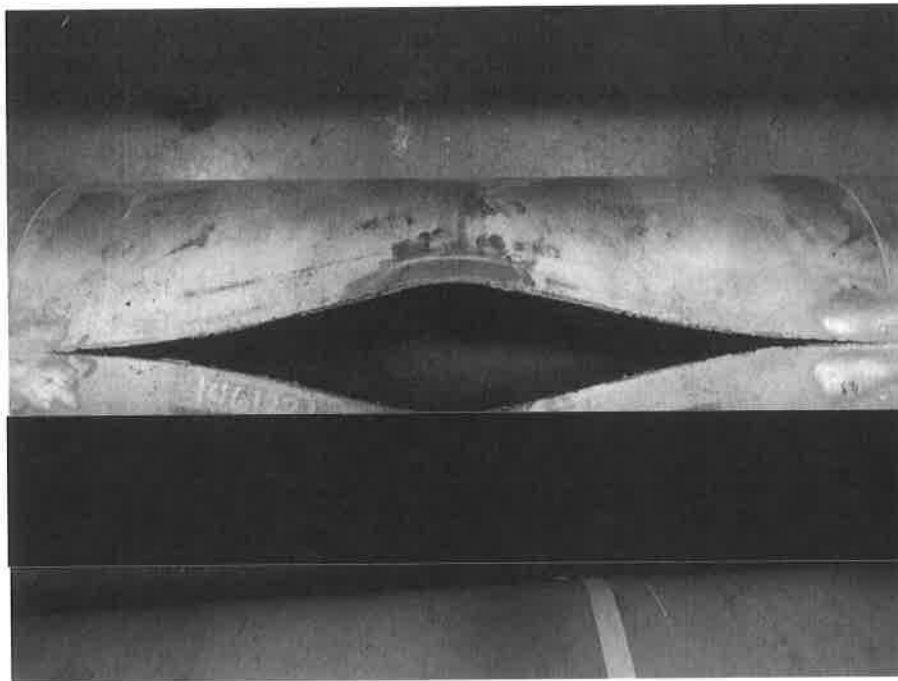
The in-service anomaly in Sample 1 failed at an internal pressure of 161% SMYS at the anomaly location as shown in

Figure 4-8. Strains in the base pipe and HF ERW seam remained stable during two five minute holds at 72% and 100% SMYS. The anomaly, which was thought to be 73% of the wall thickness at the time of failure, did not significantly reduce the strength of the HF ERW seam even after the fatigue test program. The base pipe at the time of failure reached over 22,000 to 23,000 microstrain (2.2% to 2.3% strain). The gages located on the HF ERW seam disbonded from the pipe at approximately 12,500 microstrain (1.25% strain).

Figure 4-8: Sample 1 (in-service anomaly) failure surface at the anomaly in the HF ERW seam.

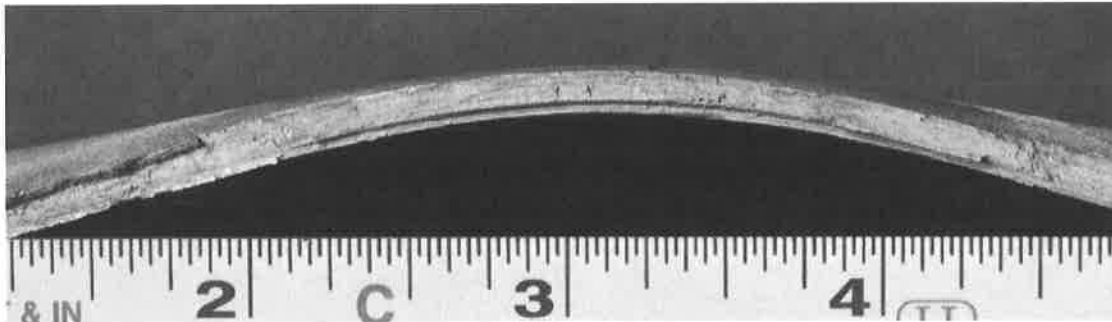
Figure 5-4, respectively. The in-service anomaly present in Sample 1 (Figure 5-1) appears to have a discontinuity that runs along the circumference of the pipe, parallel and close to the internal surface. Metallurgical examination of this sample will provide greater detail to the type of flaw present.

Figure 5-1: Photograph of Sample 1 fracture surface containing the in-service anomaly. Numbered scale divisions are inches.

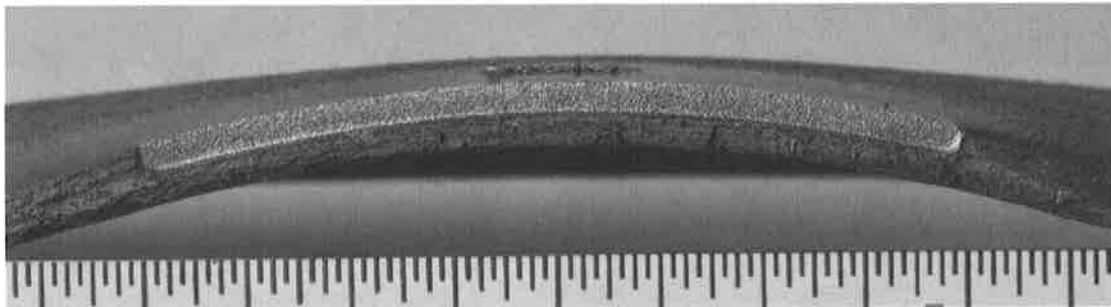
The notch present in Sample 2 (Figure 5-2) and Sample 3 (Figure 5-3) did not show signs of fatigue growth during the cycle and surge tests. However, the notch present in Sample 4 (Figure 5-4) shows signs of fatigue growth during the cycle and surge test. Up-close examination of the fracture surface, shown in Figure 5-5, displays three distinct regions – the EDM notch, notch growth by fatigue during pressure surges, and final overload fracture. These regions were also examined via scanning electron microscopy below.

Figure 5-2: Photograph of Sample 2 fracture surface containing a 50% notch. Scale divisions are 1/32 inch.

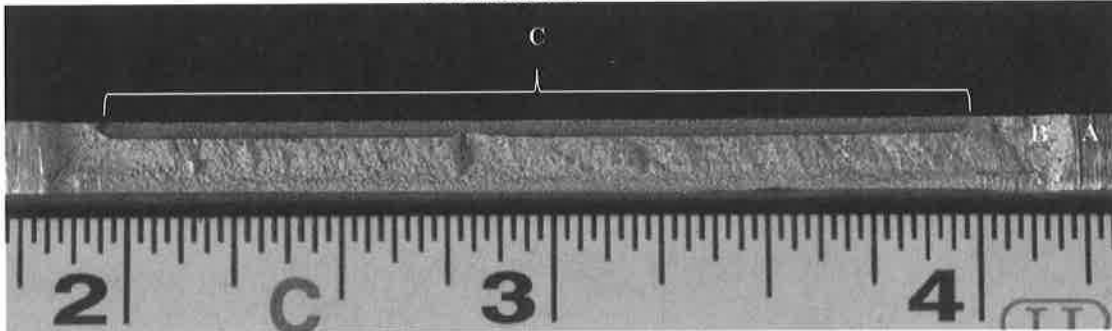
Figure 5-3: Photograph of Sample 3 fracture surface containing a 25% notch. Region A is the saw cut, region B is lab fracture, C is the EDM notch. Numbered scale divisions are inches.

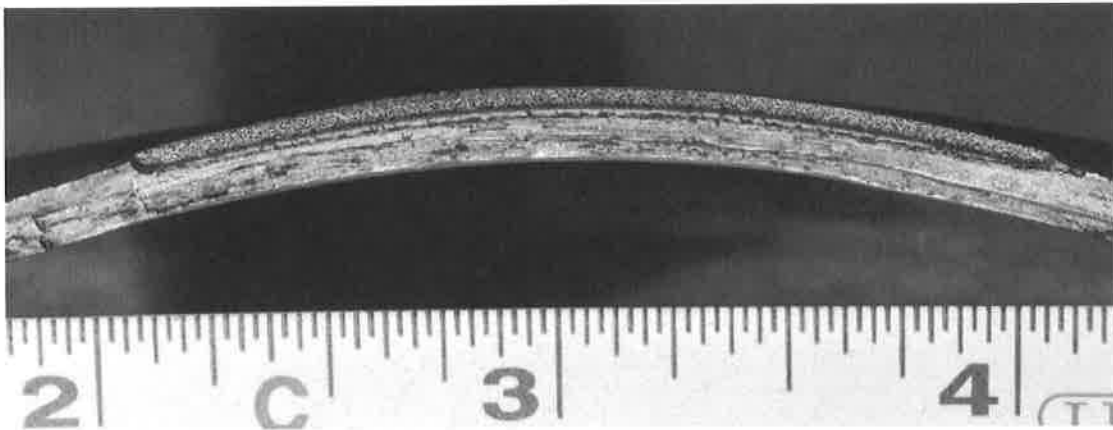
Figure 5-4: Photograph of Sample 4 fracture surface containing a 25% notch. Numbered scale divisions are inches.

The 97 year surge/cycle fatigue test on Sample 4 did result in fatigue growth of the 25% notch. The growth is visible in

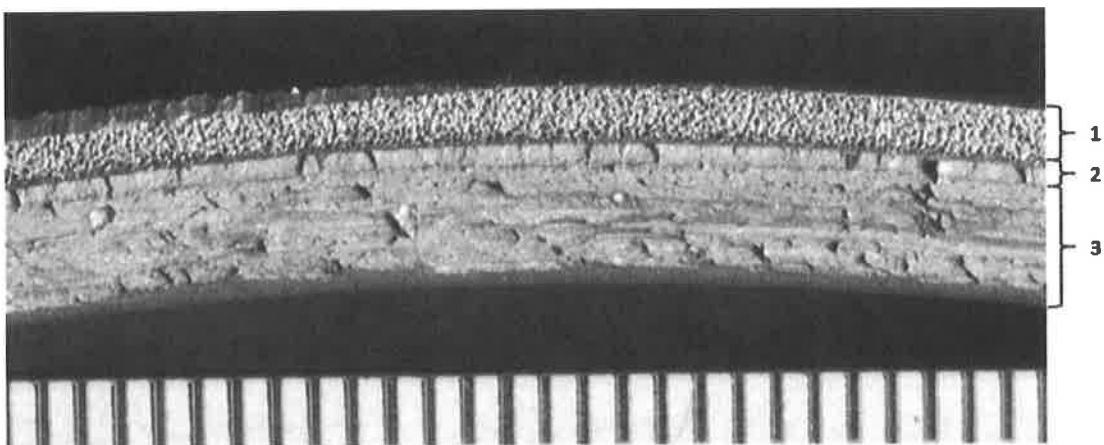
Figure 5-5: Up-close photograph of Sample 4 fracture surface containing a 25% notch. Region 1 is the original EDM notch, region 2 is the fatigue growth, and region 3 is the final overload fracture. Scale divisions are 1/32 inch.

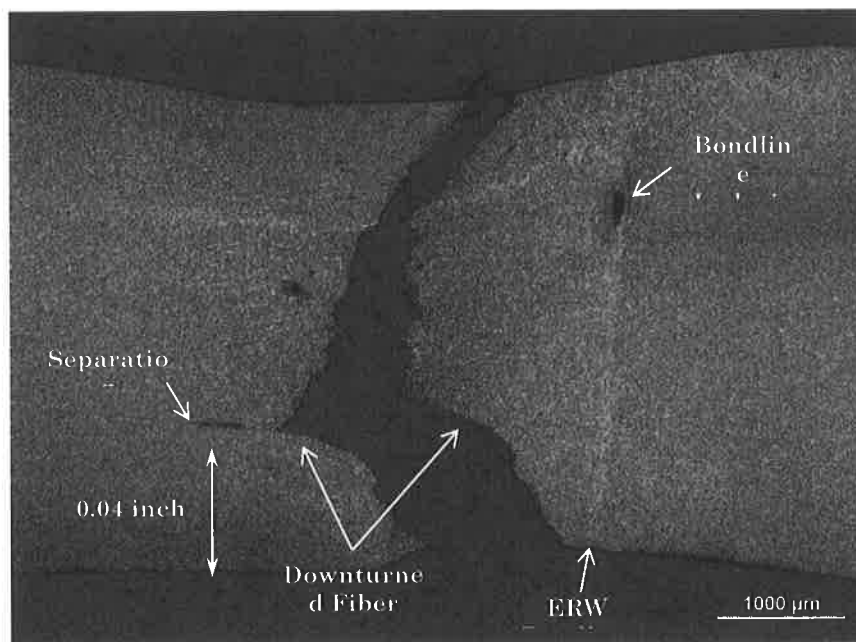
Figure 5-6. The in-service anomaly appears to be consistent with a downturned fiber, i.e. an entrapped inclusion turning toward the pipe internal surface. The non-uniform fracture surface, especially at the ID, indicates the flaw likely did not connect to the inner pipe surface, as shown in

Figure 5-6: Matched fracture photomicrograph of in-service anomaly present in Sample 1. Etchant is 2% Nital, original magnification is 25x.

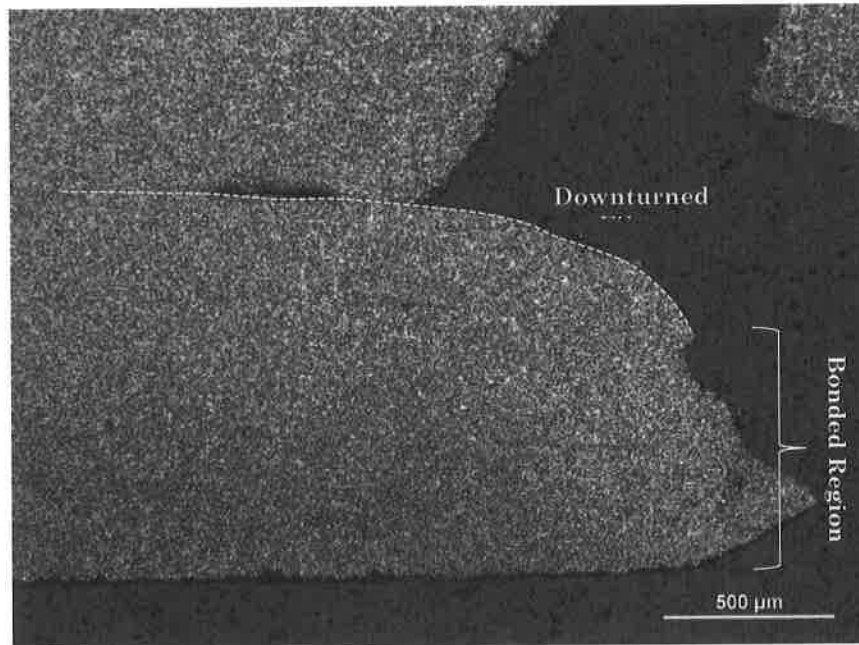
Figure 5-7: Photomicrograph of in-service anomaly present in Sample 1 showing downturned fiber. Etchant is 2% Nital, original magnification is 50x.

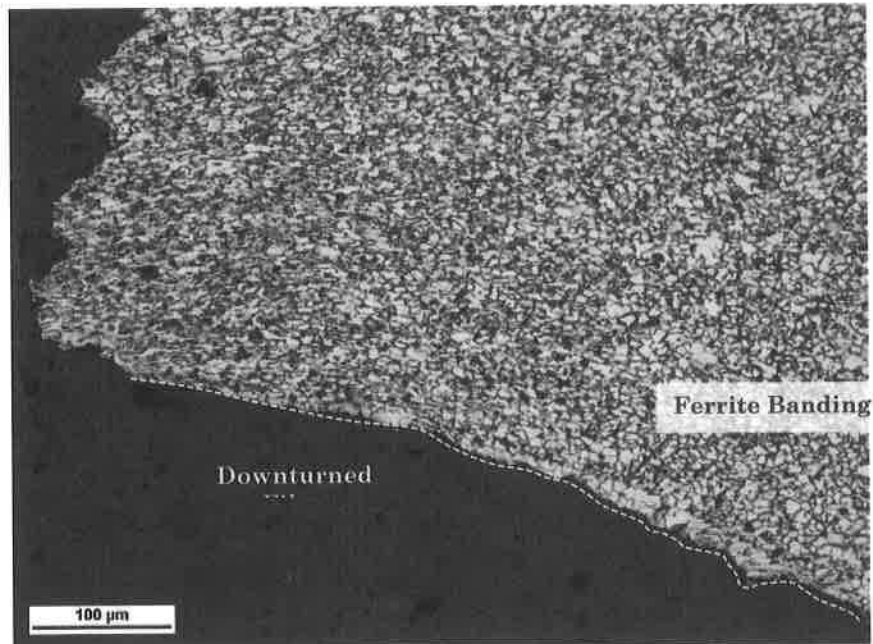
Figure 5-7. An inclusion appears to be present on the ERW bond line at approximately 1/3 of the wall thickness from the pipe OD. Ferrite banding along the downturned fiber interface supports the conclusion the flaw is a downturned fiber, as shown in Figure 5-8.

Figure 5-8: Photomicrograph of in-service anomaly present in Sample 1 showing ferrite banding near downturned fiber. Etchant is 2% Nital, original magnification is 200x.

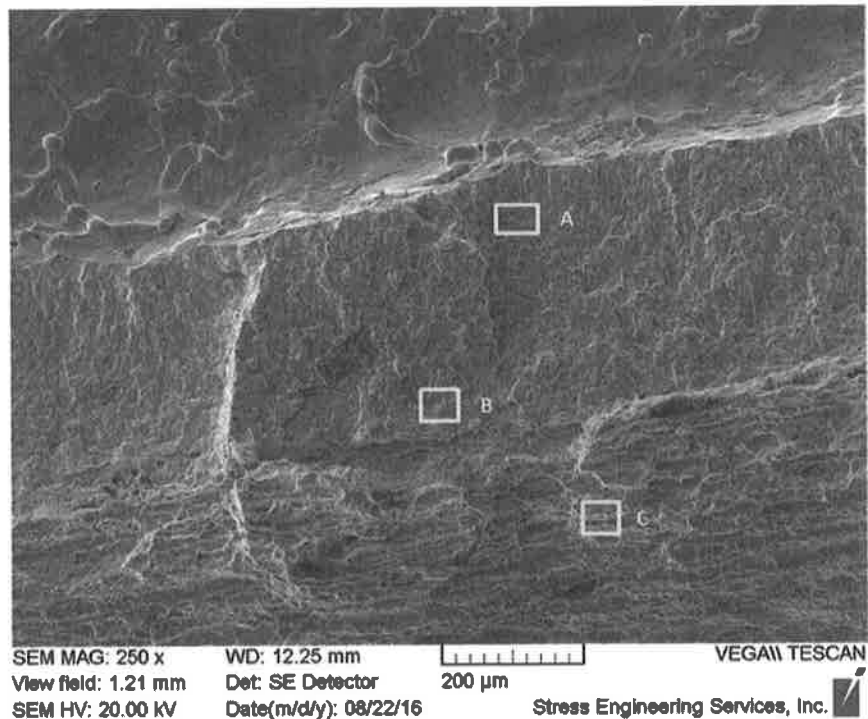
The fracture surface of Sample 4 was examined with scanning electron microscopy (SEM). Figure 5-10 shows an overall secondary electron image displaying three distinct regions. Areas for up-close examination are indicated by letters A, B, and C. Location A displays some indication of fatigue as slight striations are visible. Location B is an area of transition from fatigue to overload fracture. Location C was is an area of overload fracture displaying ductile dimpling. The fracture surfaces are consistent with the testing program, i.e. melting due to EDM notching, fatigue during pressure cycling, and final overload fracture during burst testing.

Figure 5-10: Secondary Electron SEM image at base of EDM notch in Sample 4.
