ILI and NDE characterization of pipeline manufacturing flaws and confirmation through full-scale testing

Pipeline Pigging and Integrity Management Conference

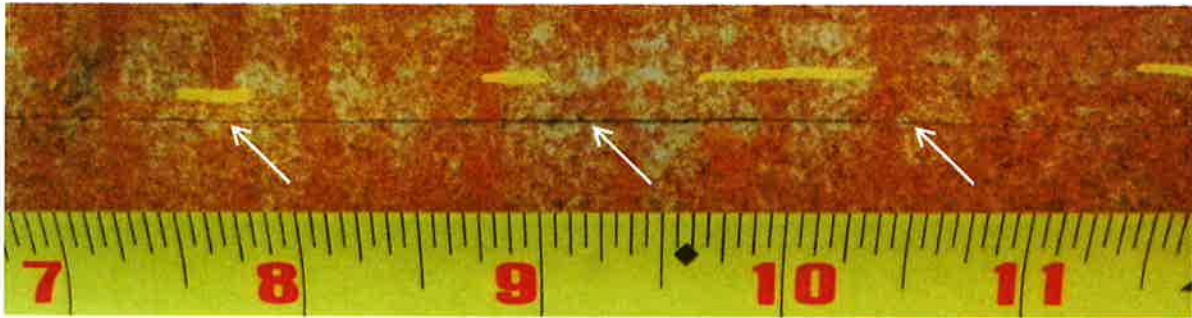
All four samples were visually examined upon arrival. External surface breaking flaws were visually identified, such as the one shown in Figure 1 from Sample 4. A combination of external surface breaking, internal surface breaking, and mid-wall flaws was identified by the PAUT vendor and confirmed visually according to the markings present on the pipes. All of the external surface breaking flaws were visually similar to the one shown in Figure 1. SES visually examined these flaws; some were noted to be intermittently external surface breaking down the length of the pipe.

Figure 1: Photograph of flaw from Sample 4. Numbered scale divisions are inches.

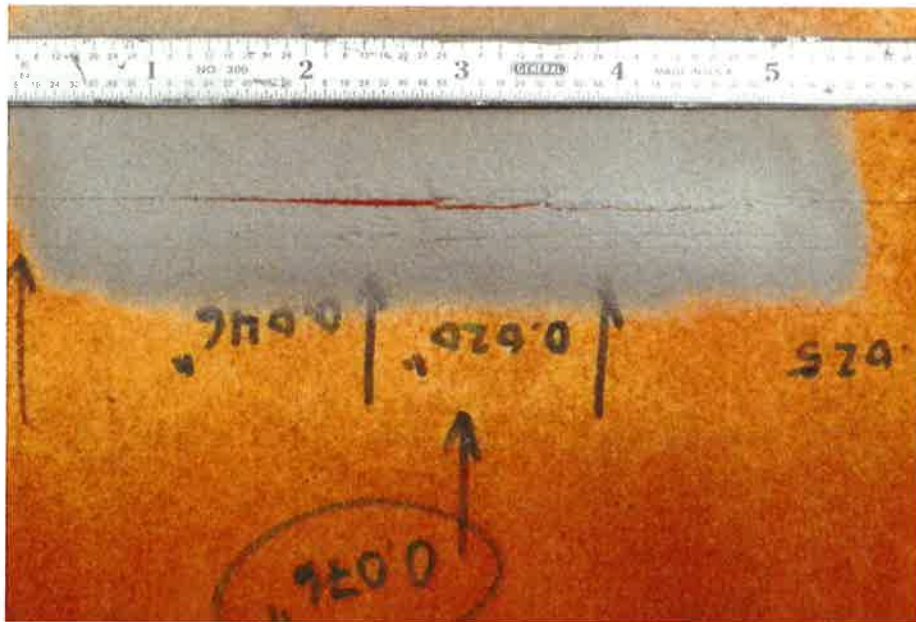
An example of this inspection on Feature 8988 from Sample 3 is shown in Figure 2 and Figure 3. Figure 2 shows the MPI indication after light buffing with a wire wheel to remove flash rust. Figure 3 shows the MPI indication after lightly touching the grinder perpendicular to the flaw. As described above, this feature was found to be consistent with a rolled-in surface flaw because the tip of the MPI indication traveled circumferentially around the pipe. The total grind depth was rather shallow at less

Figure 2: Photograph of Feature 8988 from Sample 3 showing MPI indication. Numbered scale divisions are inches.

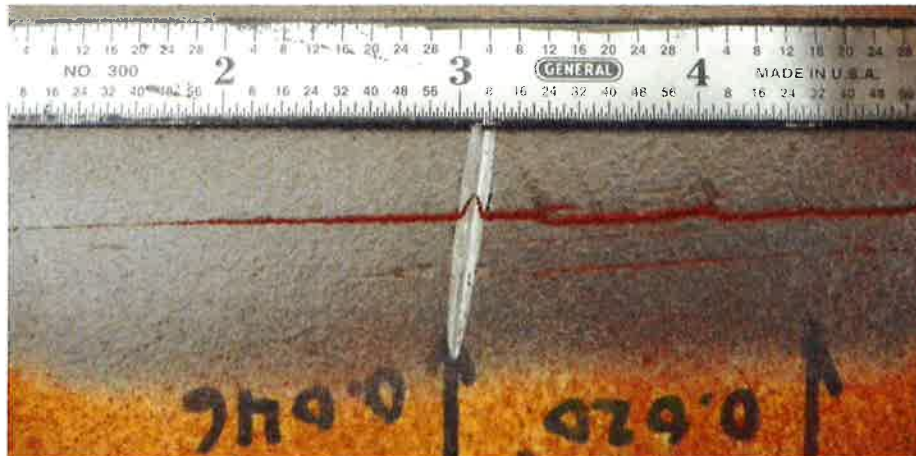
than 10% of the wall thickness. This grinding indicated that the maximum flaw depth in the area inspected was also shallow.

Figure 3: Photograph of Feature 8988 from Sample 3 showing MPI indication after second grinding pass. Numbered scale divisions are inches.

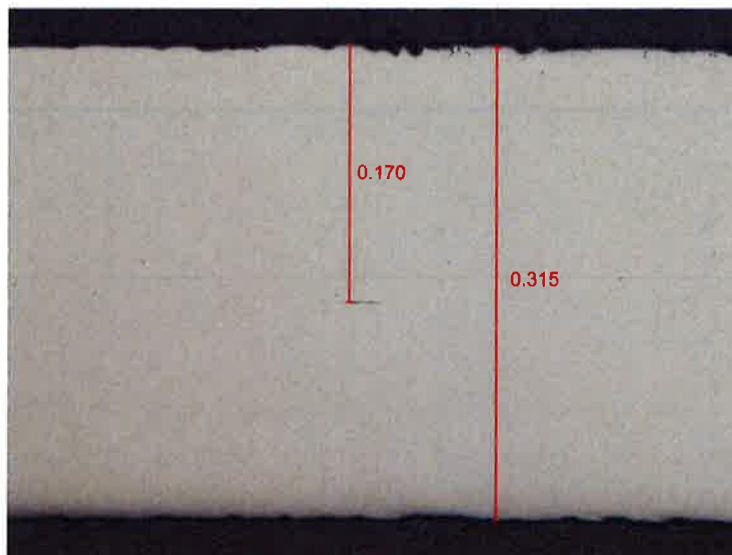
Feature 2644 was scanned in-the-ditch with PAUT and post-burst test with IWEX. A metallurgical cross-section for Feature 2644 was prepared approximately 17.2 feet from the upstream girth weld. A mid-wall inclusion was identified 0.170 inch from the outer pipe surface (Figure 4). Close-up examination revealed a line of elongated inclusions and voids. The longest void is shown in Figure 5. The indication examined does not appear to turn perpendicular to the pipe surface and does not exhibit any signs of flaw growth.

Figure 4: Photomicrograph of flaw from Sample 1 (Feature 2644) identified as a mid-wall inclusion. Unetched; original magnification is 10x.

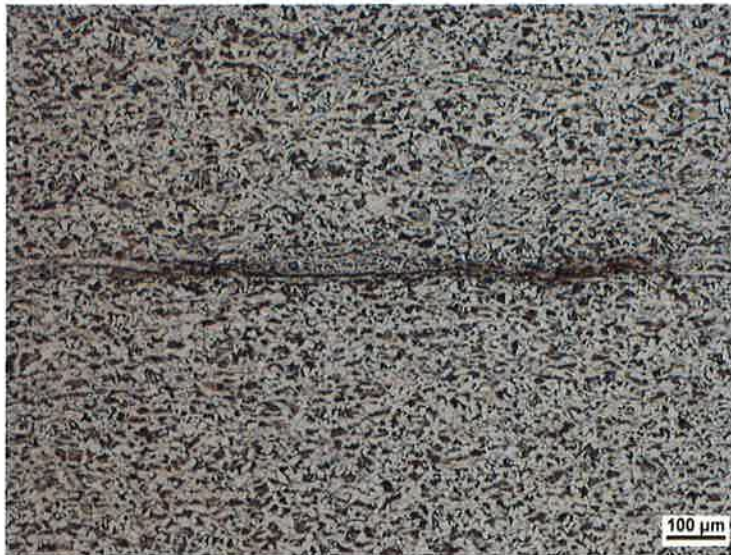
Feature 2644 was determined by metallography to be 0.170 inch from the outer pipe surface. Both PAUT and IWEX identified the flaw as 0.125 inch from the outer pipe surface. It is possible that some NDE signal was lost due to the complex cluster of elongated inclusions along the pipe's mid-wall. Visualization of the IWEX data (Figure 6) indicates that the flaw remains mid-wall and does not exhibit a surface breaking feature. Additionally, the IWEX data indicate that the tip of the flaw does not extend perpendicular to the pipe's surface. Both of these findings were confirmed through metallography (Figure 5).

Figure 5: Photomicrograph of flaw from Sample 1 (Feature 2644). Etchant is 2% Nital; original magnification is 100x.

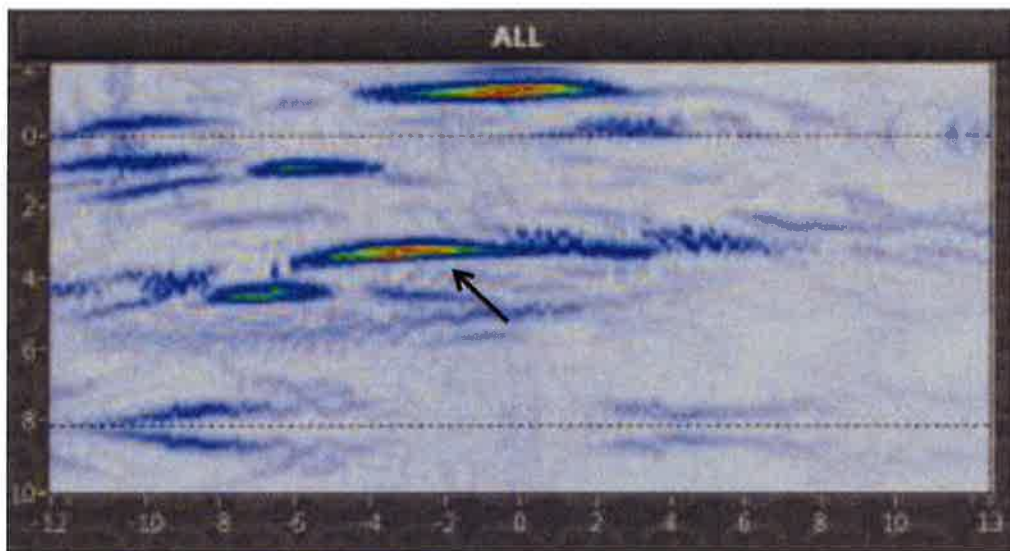
Figure 6: IWEX visualization of Feature 2644 from Sample 1 located 17.22 feet from upstream girth weld.

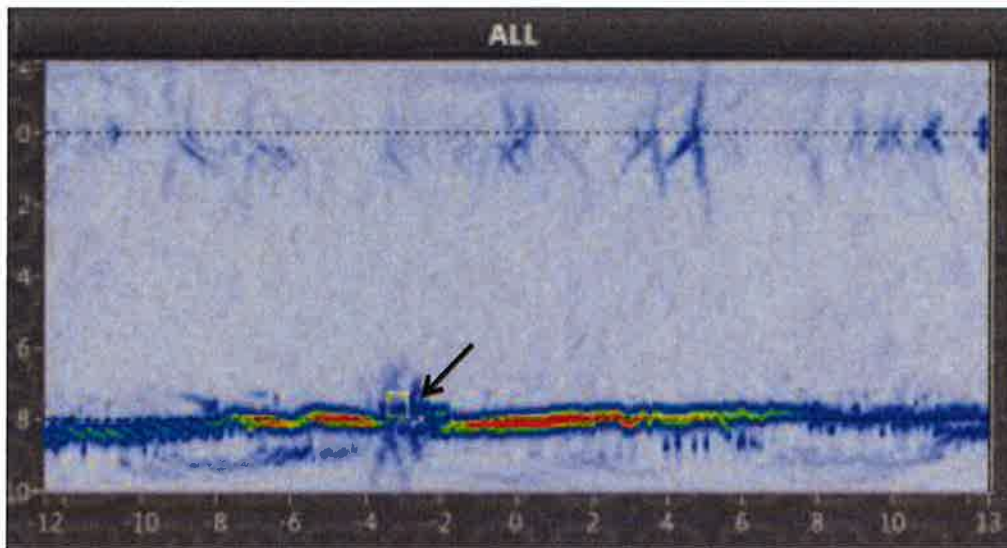
All features in Sample 2 survived the cyclic and burst test, discussed later in this report. Feature 8978 was scanned in-the-ditch with PAUT and post-burst test with IWEX. Feature 8978 from Sample 2 was identified as an internal surface breaking indication. This feature was determined to be consistent with a scratch with a depth of 0.004 inch (1.3% of nominal wall thickness). Both PAUT and IWEX overestimated the flaw depth; however, similar to before, IWEX allows the user to visualize the flaw as shown in Figure 7.

Figure 7: IWEX visualization of Feature 8978 from Sample 2. Flaw indicated by arrow.

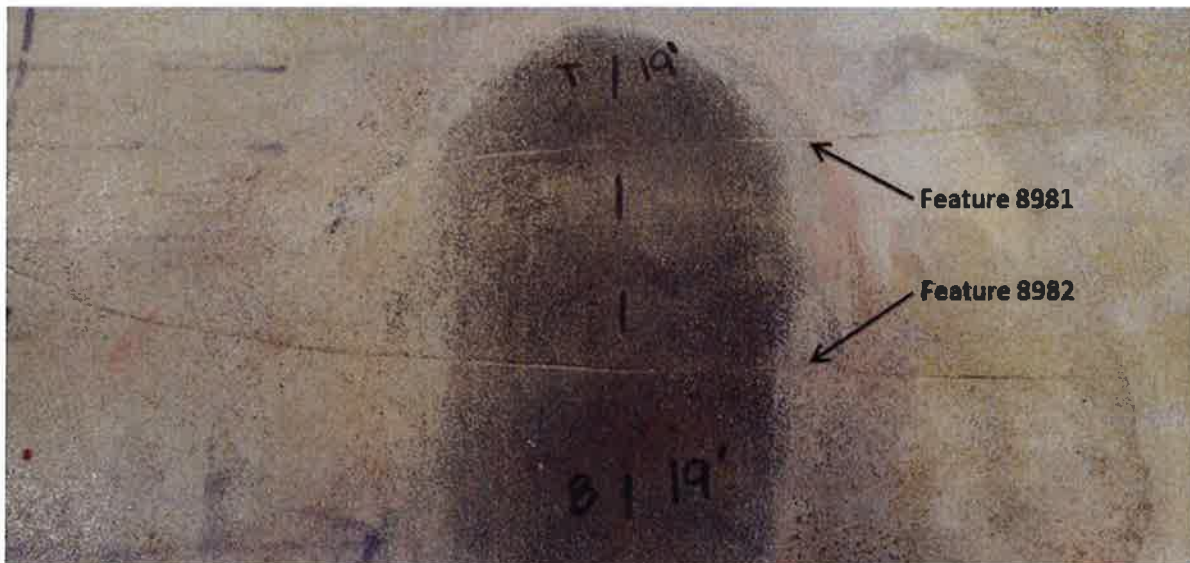
Features 8981 and 8982 were both reported by the ILI vendor. Both features were scanned in-the-ditch with PAUT, later in the lab with PAUT, IWEX, and the perpendicular circumferential grinding procedure. Figure 8 shows Features 8981 and 8982. These features were initially scanned via IWEX. Visualization of the data (Figure 9) shows a horseshoe-type shape running along the length of the pipe. The top image shows the received data during the scan and the bottom image outlines the flaw with a dotted red line. IWEX determined that the flaw had a maximum depth of 0.043 inch (13.8% nominal wall thickness) at 21 feet from the upstream girth weld. The view window, enlarged in Figure 10, shows the transverse cross-section of the flaw. This image shows that the flaw is shallow, as the indication does not greatly move away from the outside surface of the pipe. Additionally, the flaw can be visualized turning circumferentially into the pipe (i.e., a sliver), rather than perpendicular to the outer surface (i.e., a crack). A sliver is defined by API 5T1 (2010) as “an extremely thin elongated piece of metal that has been rolled into the surface of the parent metal to which it is attached usually by only one end.” Also, it appears that the tip of the flaw does not extend perpendicular to the outer surface, indicating that there is no flaw growth. It should also be pointed out that ILI data identified a similar horseshoe type flaw (shown in Figure 11); however, it was reported as a notch-like feature.

Figure 8: Photograph of Features 8981 and 8982 from Sample 2.

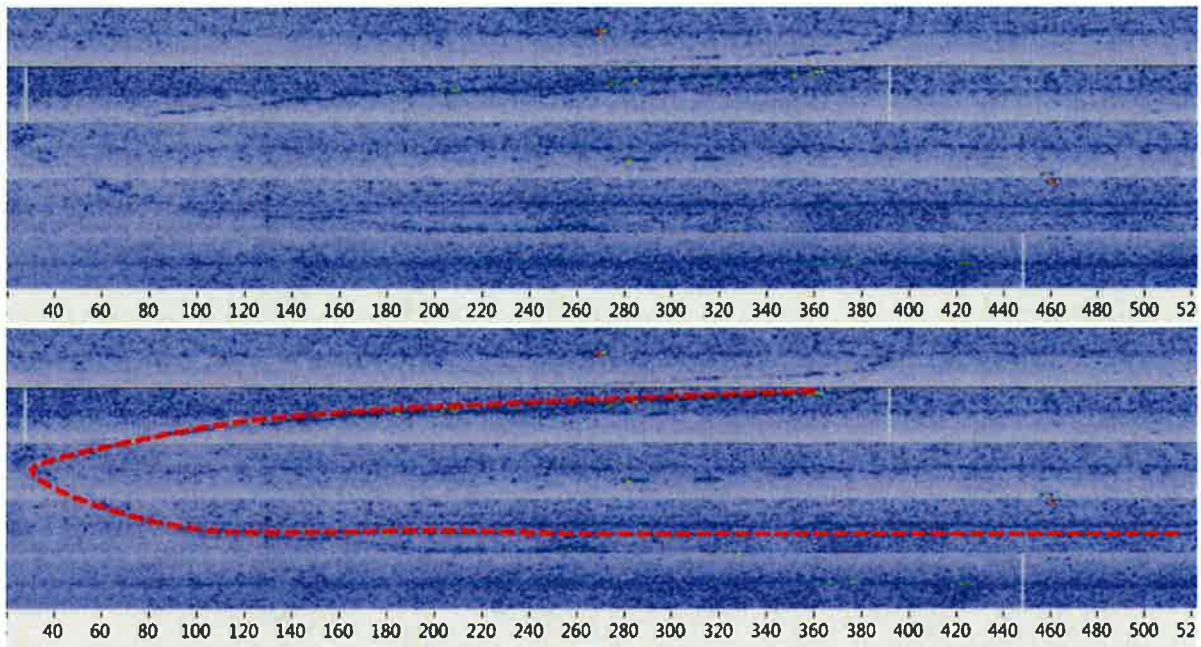
Figure 9: IWEX visualization of Features 8981 and 8982 from Sample 2.

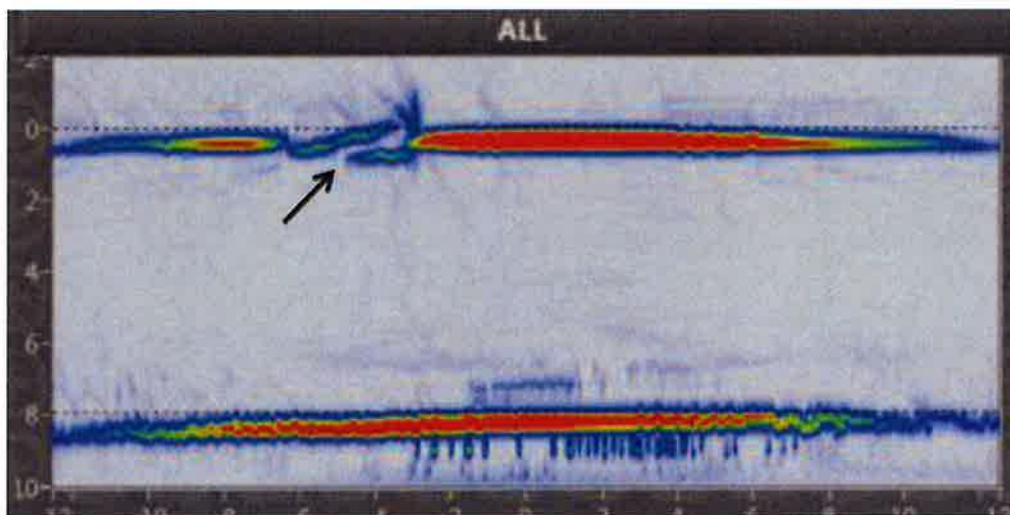
[1] Measured at 21 feet from upstream girth weld, shown in Figure 10.
Percent wall thickness calculated based on nominal wall thickness of 0.312 inch.

Figure 10: IWEX visualization of Feature 8982 from Sample 2 located 21 feet from upstream girth weld. Flaw indicated by arrow.

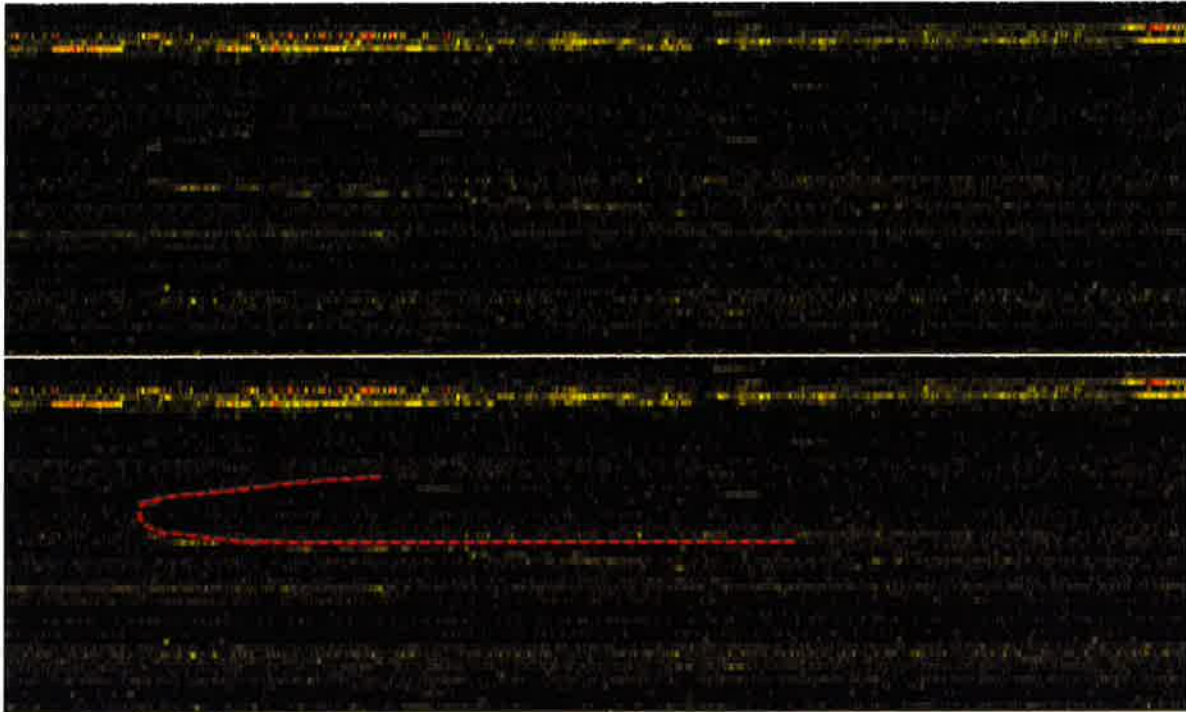
Figure 11: ILI vendor c-scan visualization of Feature 8981 and 8982 from Sample 2.

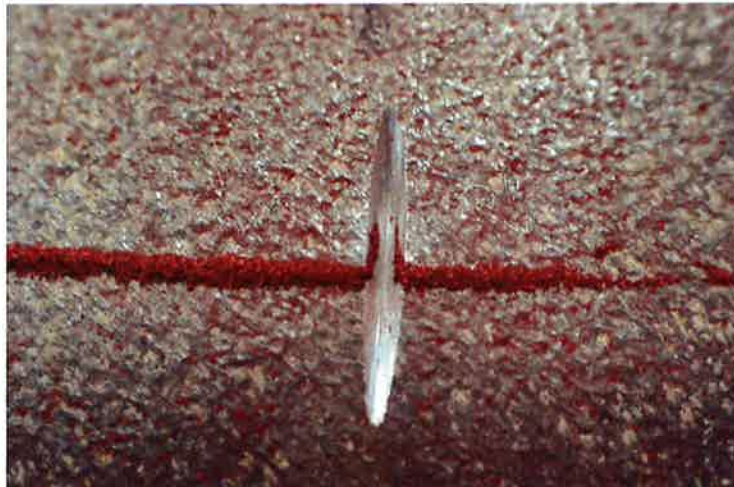
Lastly, a select flaw present from Sample 2 (Feature ID 8981 and 8982) was characterized using the circumferential grinding procedure described above. Photographs of the inspection and the results are presented in the metallography section above. Flaw depth after grinding was measured every 1 foot starting 19 feet from the upstream girth weld. The grind depth was measured after the flaw was no longer visible via MPI (Table 3). The flaw depth varied along the length of the feature, with a maximum depth of 0.0215 inch (7% of nominal wall thickness). Photographs summarizing this inspection on the bottom portion of the flaw (Feature ID 8982) located 19 feet from the upstream girth weld are shown in Figure 12.

Figure 12: Photograph of Feature 8982 from Sample 2 showing MPI indication after second grinding pass. Note that the MPI indication of flaw is not seen at center of ground notch.

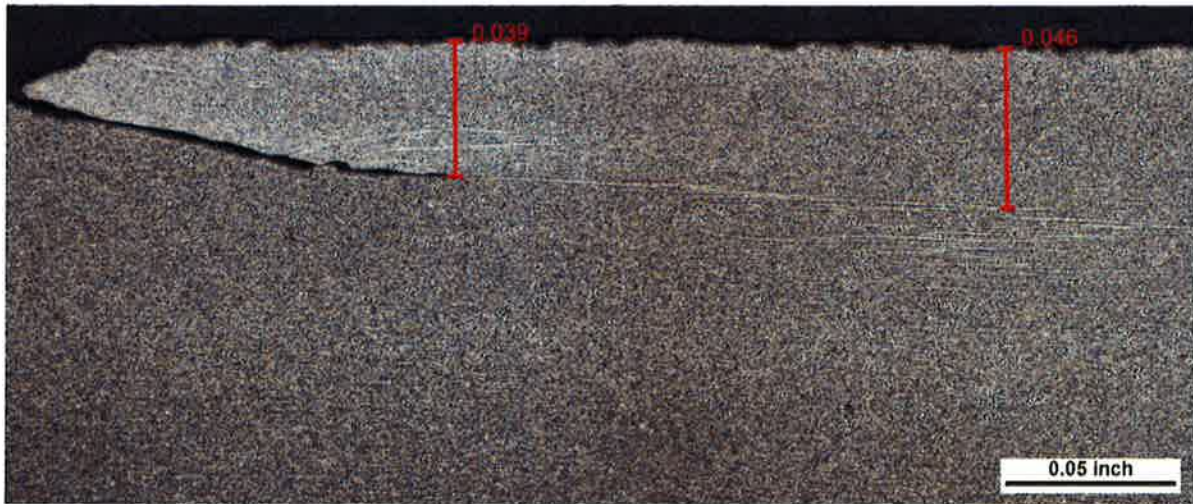
Feature 8988 was reported by the ILI vendor and scanned in-the-ditch with PAUT. This feature was not scanned with IWEX. On Sample 3, the flaw depth was reported as 0.076 inch (24.4% nominal wall thickness). A metallurgical cross-section was prepared at this location and several features were identified in an unetched photomicrograph. The most severe indication was consistent with a sliver flaw created during plate manufacturing. This flaw was determined to be 0.039 inch deep (12.5% of nominal wall thickness) as measured from the outer surface (Figure 13). Ferrite banding continued parallel to the pipe surface, reaching a maximum depth of 0.046 inch (14.7% of nominal wall thickness). It can be seen that the flaw is oriented nearly parallel to the pipe surface. No flaw growth was observed in the metallurgical investigations. It is likely that both ILI and in-the-ditch inspection identified these slivers and/or elongated inclusions as a notch-like flaw or crack-like indication.

Figure 13: Photomicrograph of flaw from Sample 3 (Feature 8988) identified as a sliver. Flaw depths are reported with respect to outer pipe surface. Etchant is 2% Nital; original magnification is 25x.

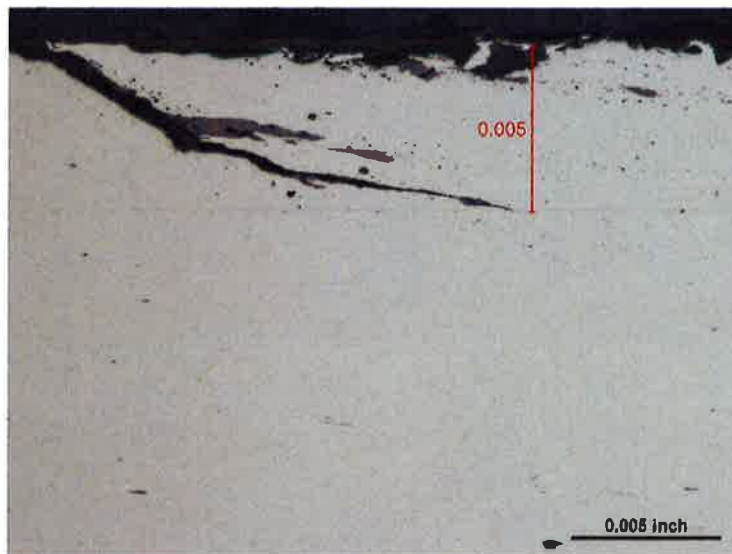
All features in Sample 4 survived the cyclic and burst test, discussed later in this report. Feature 9677 was scanned in-the-ditch with PAUT and post-burst test with IWEX. A metallurgical cross-section for Feature 9677 was prepared approximately 13.8 feet from the upstream girth weld, shown in Figure 14.

The indication is consistent with a sliver flaw created during plate manufacturing. This flaw was 0.005 inch (1.6% nominal wall thickness) deep as measured from the outer surface. Similar to Feature 8988, ferrite banding was identified parallel to the pipe surface. It can be seen that the flaw is mostly oriented parallel to the pipe surface. IWEX identified other features such as inclusions near the mid-wall as shown in Figure 15. Metallography identified small inclusions typical of pipeline steel. These inclusions can create difficult-to-interpret signals that can affect flaw depth sizing (Figure 14).

Figure 14: Photomicrograph of external surface breaking portion of the flaw from Sample 4 (Feature 9677) identified as a sliver. Unetched; original magnification is 200x.

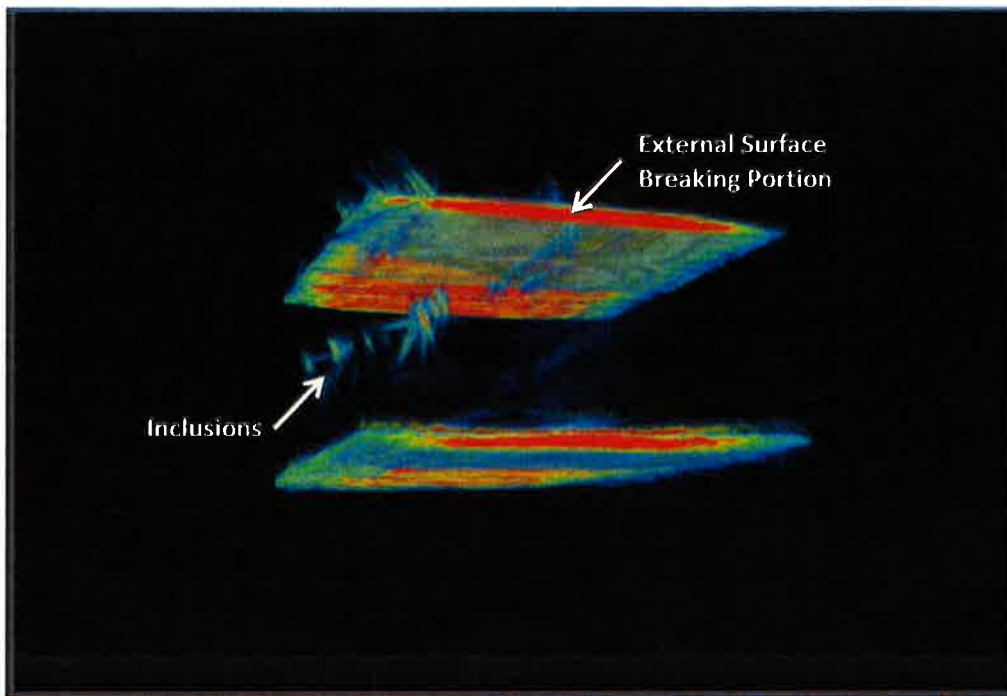
Figure 15: IWEX visualization of Feature 9677 from Sample 4 located 13.79 feet from upstream girth weld.

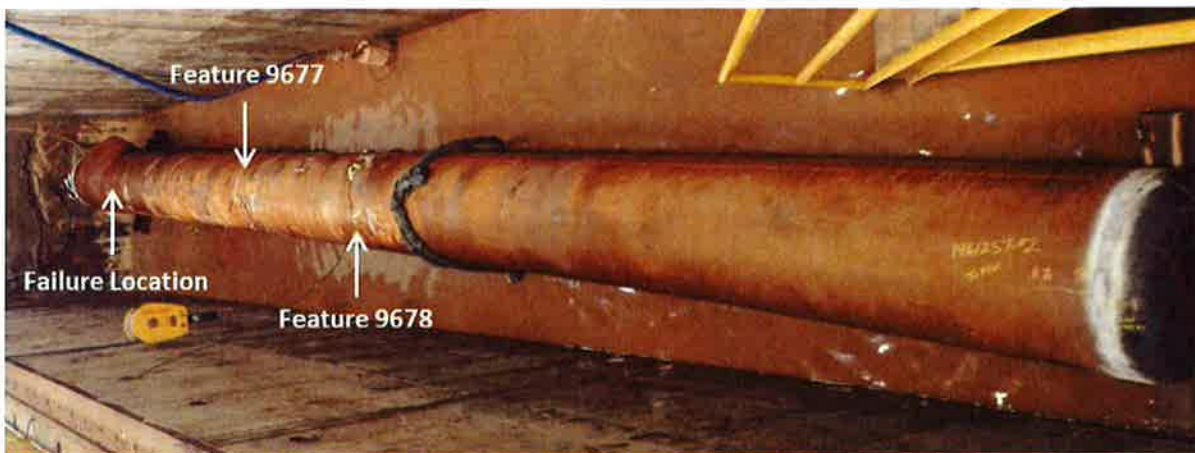
Both samples survived the cyclic testing. Sample 2 and Sample 4 then failed during burst testing at a maximum pressure of 1,796 psi and 1,779 psi, respectively. Table 6 summarizes the burst test results. Neither sample failed at a flaw location identified by the NDE inspection, but instead failed in the adjacent pipe pups. A representative post-burst test is shown in Figure 16.

Figure 16: Photograph of Sample 4 after burst test sample. Failure location and several flaws identified by ILI are labeled.
