BALLOONING ARMORED CHOKE HOSE

Prepared by: Paul J. Kovach, P.E., Principal

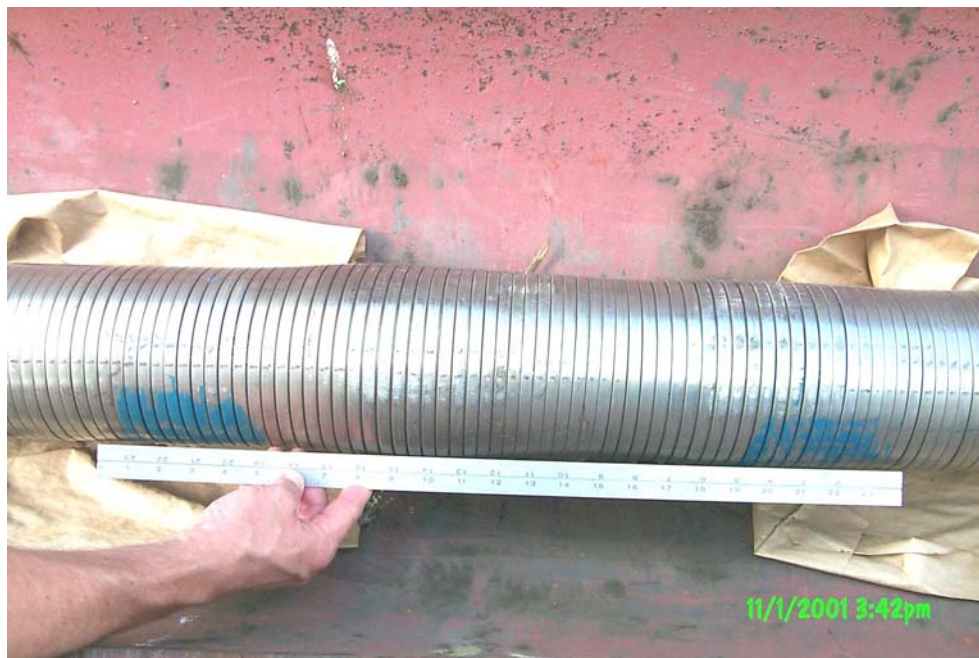
Stress Engineering then performed a destructive examination of the hose construction and determined that the manufacturer had to splice the outer wrap material and did this by overlapping the new material layer over the initial material for a distance of just over 6 inches resulting in a small bulge that apparently lead to the suspicion of ballooning under pressure.

Note the bulge and the blue markings added in the field to identify the suspected ballooning region.
