Failure Analysis

Failures Have Never Been More Expensive

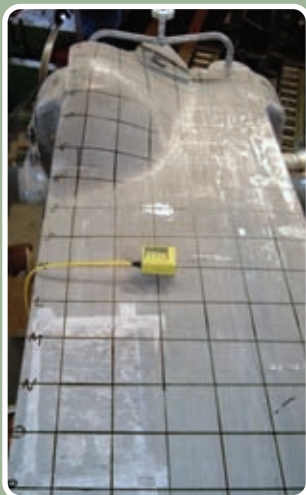
A 6-inch grid on the surface of a vessel explosion bulged aluminum plate fin heat exchanger. The grid was used to support a finite element analysis model.

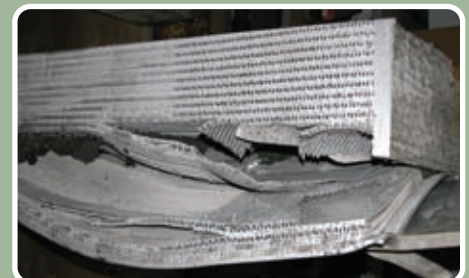
A cross section through the bulged region of an aluminum plate fin heat exchanger showing the separation at the low and high pressure passages.

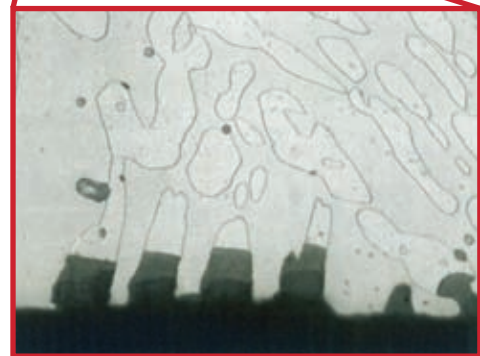
ID cracks adjacent to repair welds

Selective Phase Attack

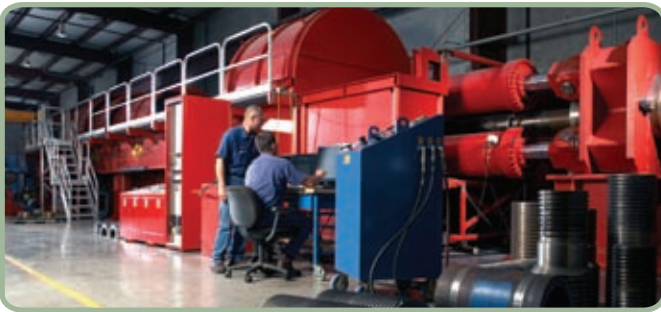
Six Million Pound Tension / Compression Test Frame
