Pipelines

Long Term Performance of Composite Materials in Repairing High Pressure Pipelines

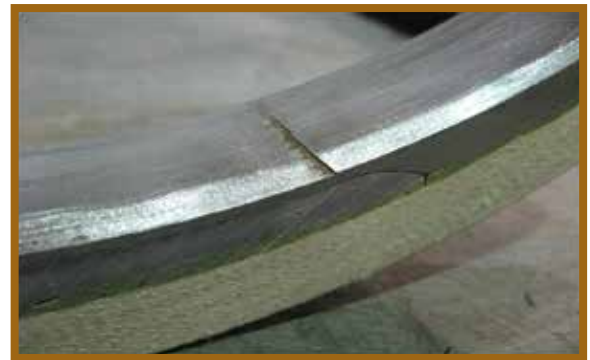
Figure 3: Fatigue failure in composite-repaired sample with 75% corrosion

Figure 3 is a photograph showing the cross-section of a fatigue sample that was removed after it had been cycled for more than 160,000 cycles. Test results such as these demonstrate the capacity that composite materials have to repair aggressive corrosion and cyclic pressure conditions.
