NUMERICAL AND EXPERIMENTAL ASSESSMENT OF GIRTH WELDS INTERACTING WITH WRINKLE ANOMALIES

This Technical Paper was prepared for presentation at the *Rio Pipeline Conference & Exhibition 2017*, held between October, 24-26, 2017, in Rio de Janeiro. This Technical Paper was selected for presentation by the Technical Committee of the event. The material as it is presented, does not necessarily represent Brazilian Petroleum, Gas and Biofuels Institute's opinion or that of its Members or Representatives. Authors consent to the publication of this Technical Paper in the *Rio Pipeline Conference & Exhibition 2017*.

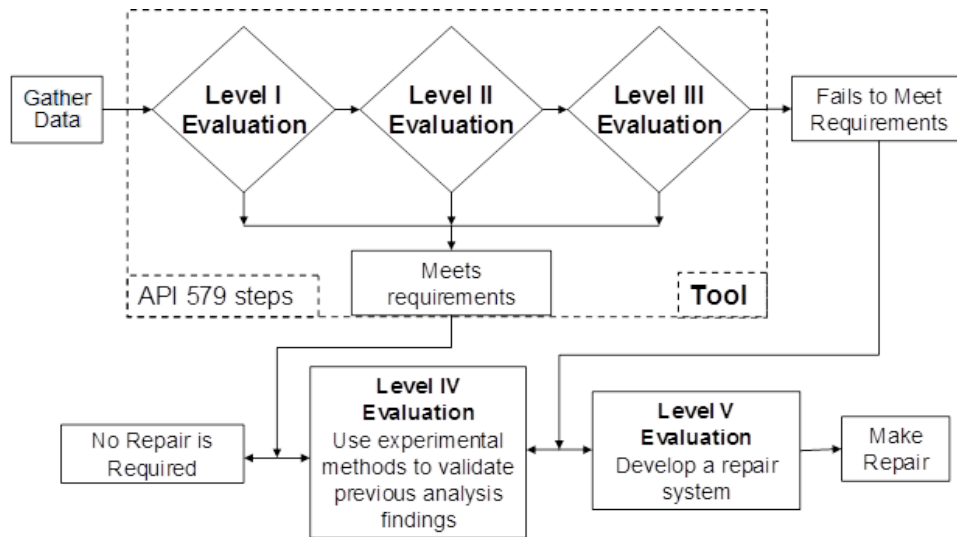
Figure 1. Elements of the EB-IMP process

The EB-IMP is a five step process for evaluating pipeline imperfections. Figure 1 is a flow chart of the proposed process that builds on the basics of API 579, but expands the process by integrating testing (Level IV) and repair (Level V). This study proposes to conduct an assessment using both the Level III (numerical modeling via finite element analysis) and Level IV assessments (full-scale testing).

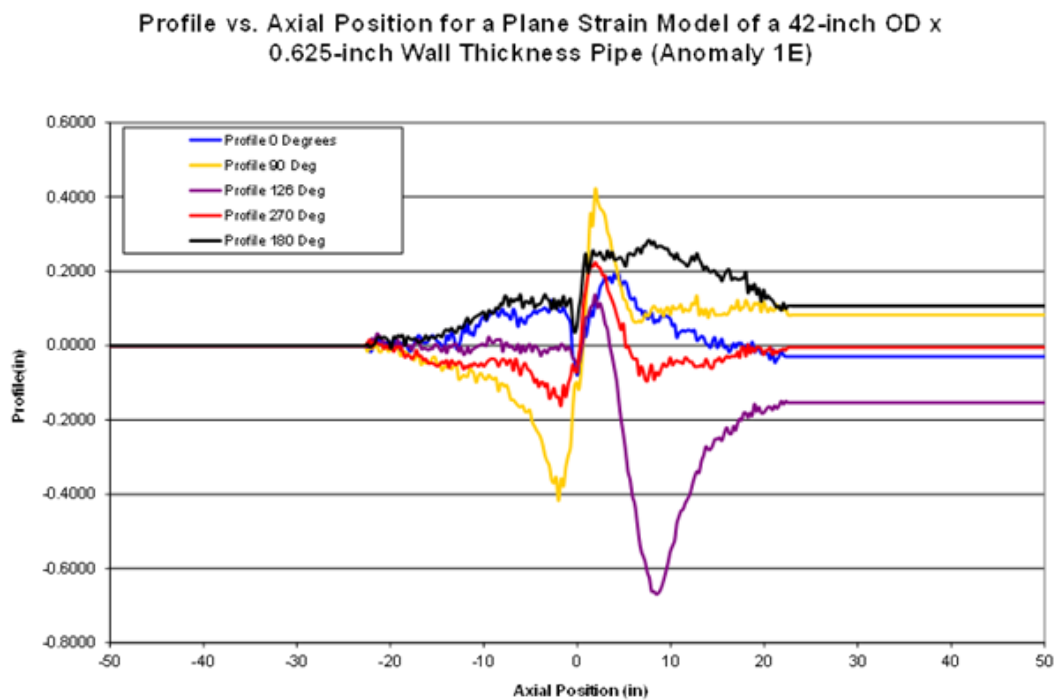
Figure 2. Radial profile of anomaly 1E vs. axial and select angular positions

Figure 2 shows the profile of anomaly 1E, as a function of axial and angular positions. The profile is defined as the change in the radial coordinate relative to a nominal OD of 42-inches.

Furthermore, a significant finding that came from analyzing the ILI data is that the wrinkle anomaly affected the entire circumference of the pipeline at that location. This is an important consideration, as wrinkle bends typically span a third to half of the circumference, and are created by bending moment loadings. In contrast, a wrinkle feature that spans the entire circumference was likely created due to significant compressive loads. Figure 3 shows the stress concentration factor (SCF) for plane strain conditions of anomaly 1E (model PE-1E), as a function of axial position, and select angular positions. Note that the largest SCF corresponds to the largest radial coordinate departure (126° position). In addition, note that the profile at the 126° angular position alternates between positive and negative values. The fact that the wrinkle goes inward and outward exacerbates the SCF at that location during pressure loading.

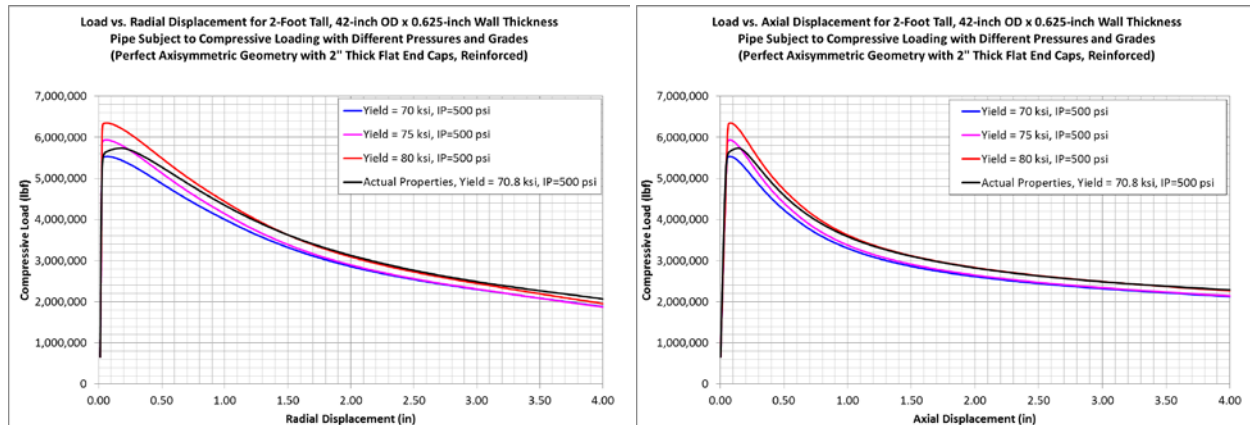
Figure 4. FEA calculated response of the pipe Samples during the wrinkle creation process

Figure 4 shows the FEA results of the load vs. radial displacement at the apex of the wrinkle as a function of pipe yield strength. An internal pressure of 500 psi is included for all results. Figure 4 also shows the load vs. axial

displacement. These plots were generated as an aid to the full-scale testing work to determine how much axial deflection of the wrinkle (a measured quantity during testing) would produce the required radial displacement at the apex of the wrinkle to produce the same SCF estimated for the field conditions discussed previously.

The h/L ratio estimated to exist in the 1E anomaly is 0.04. However, the 1E wrinkle has a profile that alternates between inward and outward values, which increases this SCF relative to a wrinkle feature having only an outward profile. For these reasons, the h/L ratio for the experimental work was designed to be 0.10. Although the sought experimental h/L ratio is roughly 2.5 times larger than the one in the field, the experimental SCF was expected to be approximately equal to the SCF associated with the field conditions.

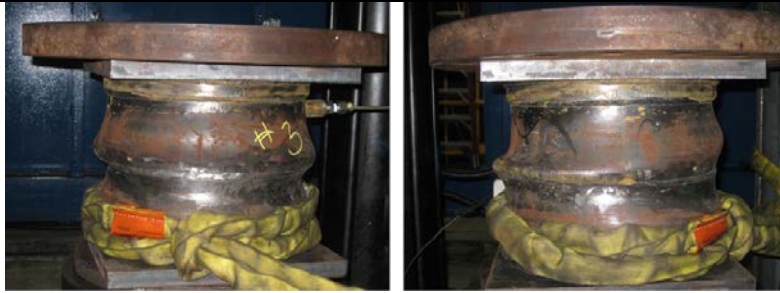
Figure 5. Sample 3 (girth weld in center) after sub-scale buckling test of 12-inch NPS pipe

The testing of the sub-scale Samples consisted of placing each Sample in a vertical load frame, where four hydraulic cylinders would lower a platen with a steel bar in the center to compress the Samples. The Samples were pressurized with water to 500 psi. During the wrinkle formation process, it was expected that the pressure inside the Sample would increase abruptly due to the compression of the Sample (i.e. reduced volume). Therefore, for each test an electronically-controlled automated pressure relief system was used to maintain the pressure in the Samples to as close to the 500 psi target pressure as possible. Figure 5 shows, for illustration, Sample 3 after testing was completed.

Results of the sub-scale testing showed that Sample 1 was compressed severely, while the compression levels for Samples 2 and 3 were reasonable. The purpose of Sample 4 was to verify the required length of the Sample to prevent wrinkles from forming at unwanted locations (omitted for brevity).

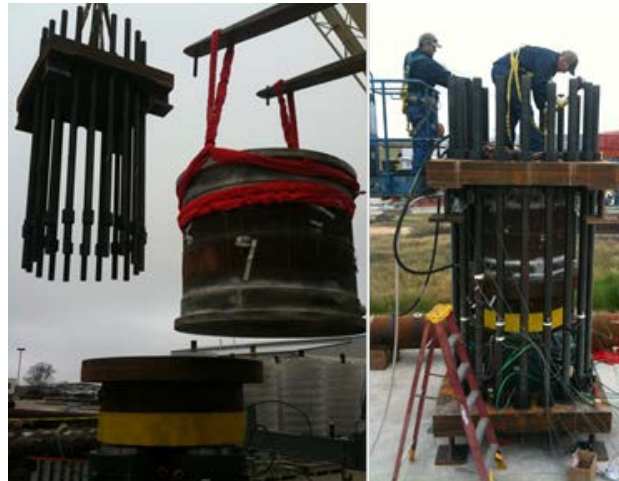
Figure 6. Assembly of load frame for full-scale testing

The load frame design included 4 hydraulic cylinders having a load capacity of 2.25 million lbf each (9 million lbf total capacity). The pipe Sample was placed in between the circular plate and the top platen. The frame works by extending the hydraulic cylinders and loading the Sample in compression between the circular plate and the top platen, while the all threads react the load and are subjected to tension. Figure 6 shows photographs of the assembly of the frame with the Sample.

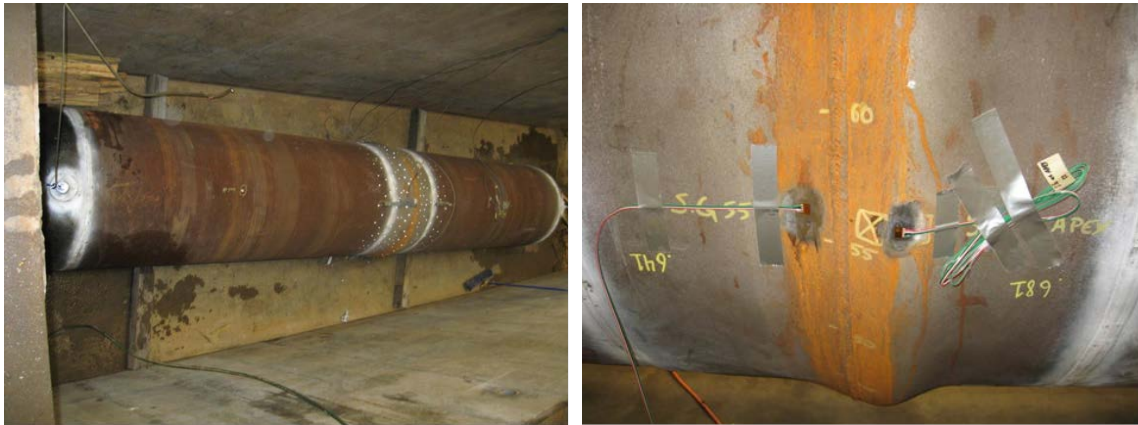
Figure 7. Sample to be pressure cycled in burst pit with pups, end caps and instrumentation.

Once the wrinkle was created, the flat end caps were removed, and approximately 9-feet of pup length on either side of the wrinkle Sample (24-inches in length) was welded. Strain gauges were installed at five (5) select locations, as well as three (3) displacement transducers equally spaced around the circumference for measuring axial deflection during pressure cycling. The Sample was placed the test pit was and connected to a cycling pump. The pressure was programmed to vary between 100 psi and 850 psi for 9,546 cycles. This cycling regime represents 20 years of service (954 cycles) with a factor of safety of 10. The experimental pressure ranges were determined based on an assessment of historical pressure data provided by the pipeline operator. Using historical pressure history data is an important part of

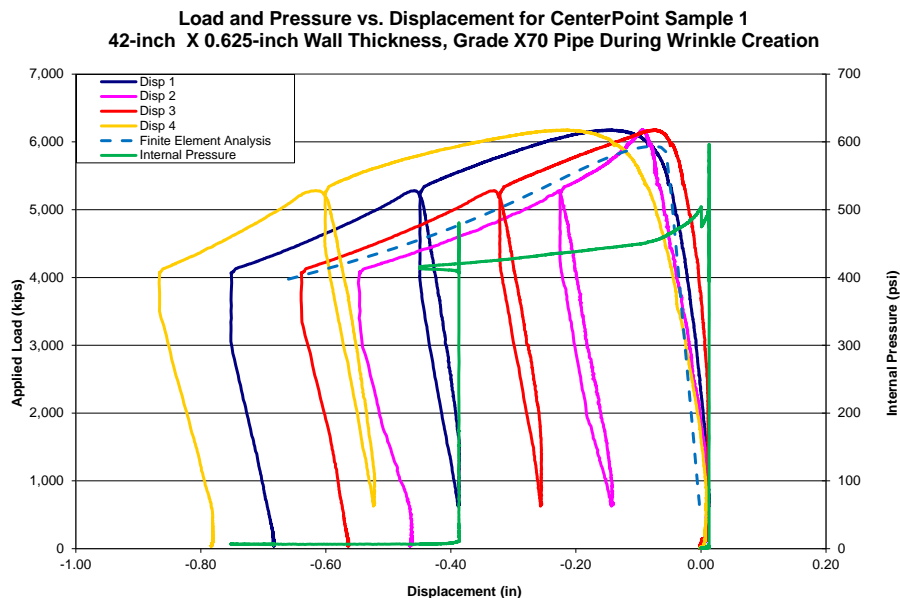
Figure 8. Load vs. axial displacement for Sample 1 and FEA results

Figure 8 shows the load (1 kip = 1,000 lbf) vs. axial displacement at the four different displacement transducers, as well as the full-scale finite element analysis results. Note that the drop in load and reload in the experiment was performed in order to visually inspect the wrinkle during the testing process. The final wrinkle geometry formed at the girth weld, 360° around the circumference, with some expected variation in profile.

Note that the displacements at each of the four experimental locations are not uniform relative to one another. This is due to variations in stiffness at the different locations around the circumference, which is due to slight differences in wall thickness and material properties. Also, note the similarities in the results with the FEA, both in the behavior as

well as the magnitudes of the loads and displacements. As a point of reference, the maximum load predicted by the finite element model was 5,936 kips, whereas experimentally the maximum load was 6,177 kips, or a difference of approximately 3.9%. The discrepancy is likely due to variations in wall thickness around the Sample, as well as slight variations in material properties. The FEA work considers the material properties and the wall thickness to be constant and homogeneous. Also note that the material tests showed a small degree of anisotropy, or difference in material properties between transverse tensile tests and longitudinal tensile tests. The FEA models did not consider anisotropic material properties.

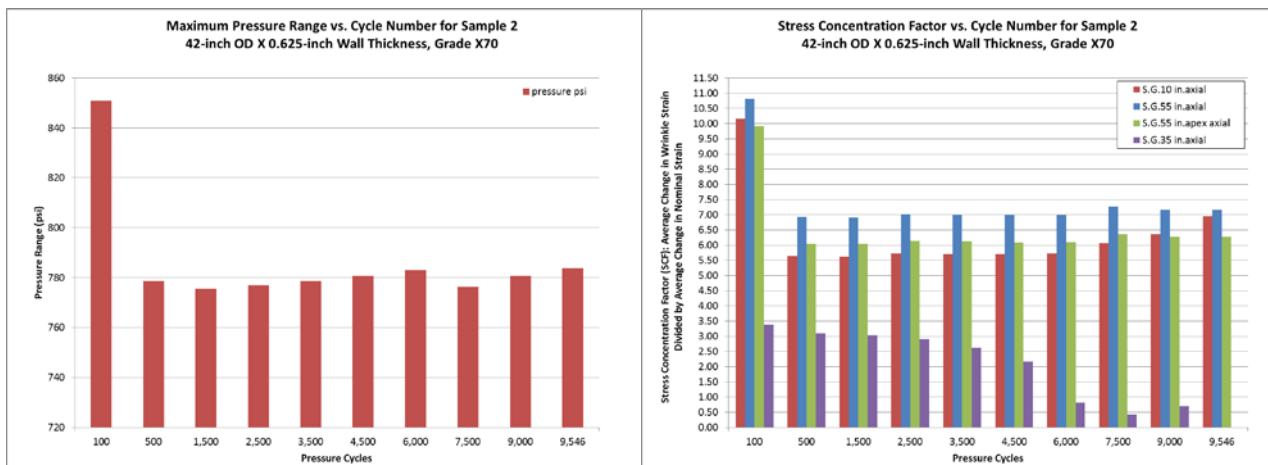
Figure 9. Pressure and SCF as a function of cycle count during pressure fatigue testing

Figure 9 shows the maximum pressure range history of the fatigue testing. Note that the maximum pressure range is initially 850 psi due to starting from a 0 psi pressure. It also shows the stress concentration factor as a function of cycle count. Similar to the pressure history plot, the SCF at the beginning of the cycling is initially higher due to the pressure starting from 0 psi. However, note how the SCF reduces to a value of approximately 7.0, which is approximately 55% lower than initially. In contrast, the pressure range reduced by approximately 13.3%. It is thought that the redistribution of residual stresses and strains contribute for this reduction in SCF after start-up conditions. In addition, this reduction in experimental SCF is likely very realistic given the expected shakedown to elastic action that likely occurred in the real pipeline.

After the wrinkle testing was finished, the Sample was instrumented as previously described and pressure cycled from 100 psi to 850 psi for 9,546 cycles. This pressure range was determined from Miner’s rule calculations representing a 20-year service life with a factor of safety of 10.

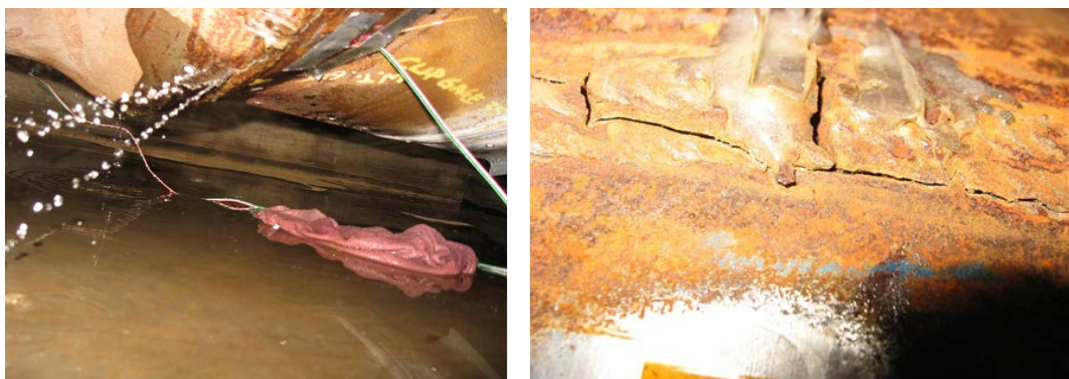
Figure 10. Leak during burst test after reaching 1,434 psi (photograph taken at approximately 15 psi).

After the first hold, the pressure was then being ramped to 1,500 psi; however, a significant leak formed at 1,434 psi, or 69% SMYS. The Sample was inspected and cracks on the order of 10 – 12 inches in length were found. Figure 10 shows the small puddle of water after pressure cycling was completed.
