Fatigue performance characterization of a manufacturing seam defect in high-frequency electric-resistance-welded pipe

by Travis Schott¹, Dr Chantz Denowh², and Chris Alexander²

Pipeline Pigging and Integrity Management Conference

1-2 March, 2017

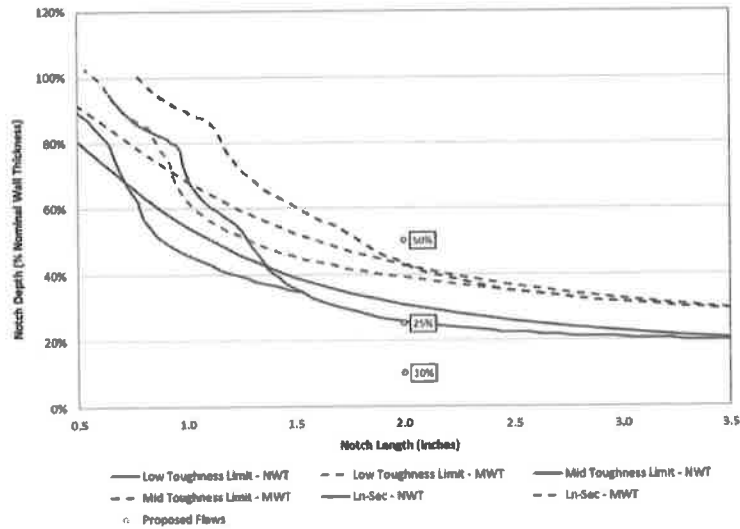
Figure 2-1: Limiting flaw size for surge pressures.

Two fracture mechanics calculations were performed to calculate the size of the defects for the fatigue cycle/surge test. The first calculation predicted the burst pressure using the Ln-Secant method developed by PRCI and the API 579 Level 2 failure assessment diagram (FAD). These calculations determined the smallest defect predicted to fail at a pressure of 106% SMYS. In addition, the calculations were used to calculate the size of the largest defect predicted to survive a failure pressure of 106% SMYS. The API 579 FAD calculations used low and moderate plain strain fracture toughness values for this pipe material. The second fracture mechanics calculation predicted the crack growth according to multiple crack growth models (da/dN curves). The models used the BS 7910 mean curve and the API 579 crack growth curves. These calculations determined the growth of any defects and estimated whether they would fail due to combinations of cycling and surge pressures. Mechanical testing of the pipe material provided Charpy v-notch values for the Ln-Sec calculations. The Ln-Sec calculations used the lowest measured CVN value with 100% shear. Both the API 579 FAD calculations and the Ln-Sec calculations were performed using the nominal wall thickness (NWT) and the average measured wall thickness (MWT). The results of the burst pressure calculations are shown in Figure 2-1.

Table 2-2. The results confirm that the 10% and 25% defects are likely to have little to no discernable growth after ≈ 2 years of service and little to no evidence of growth after ≈ 23 years of service. For the 25% WT defect, the predicted growth rates are expected to be conservative since a high pressure cycle (pressure surge) typically results in reduced crack growth for subsequent smaller cycles due to blunting of the crack tips. Therefore, these defects are expected to survive repeated cycling with intermittent surges.

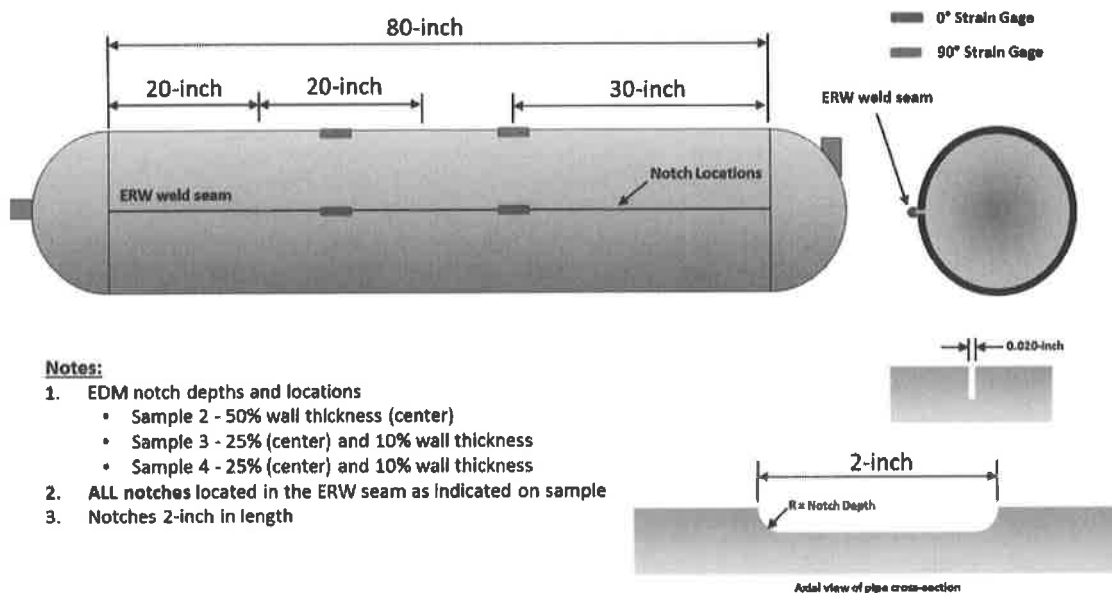
Figure 3-1: Test sample details and instrumentation locations.

The HF ERW pipe sections provided for this test program were sectioned into four (4) 80-inch length test samples. Figure 3-1 illustrates the sample dimensions and instrumentation. Each sample had locations for three (3) notches per sample (at most each sample only had two notches). The notches were placed in the center of the HF ERW seam on the bond line (seams polished and etched). The EDM notches were 2-inch in length, 0.02-inch in width, and either 10%, 25%, or 50% of the wall thickness in depth. Two biaxial strain gages were placed 10-inches from the notch locations on the ERW seam and in the base pipe 90° from the seam. The notch crack opening displacement during each pressure cycle and surge was measured by clip gages pictured in Figure 3-2. Internal pressure was continually monitored with calibrated pressure transducers.

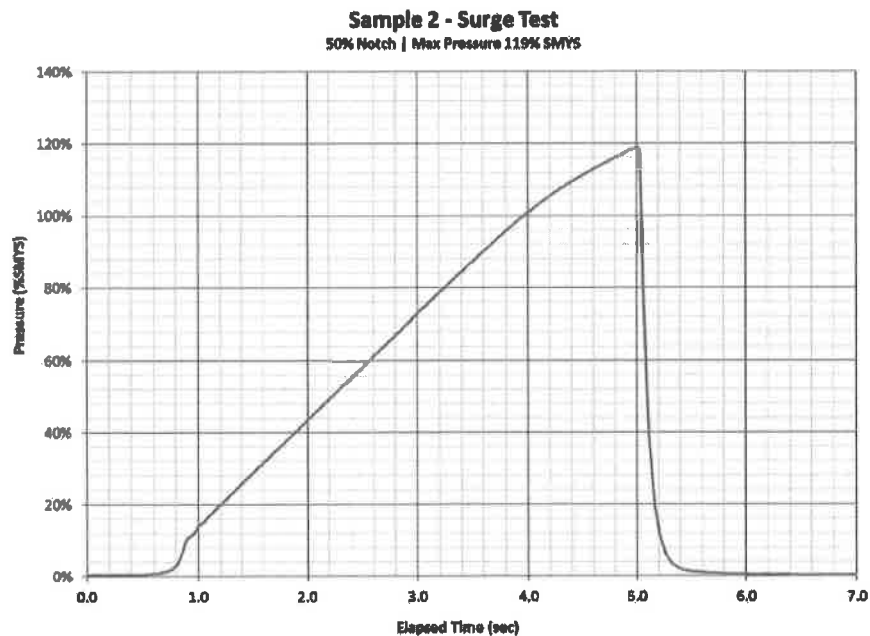
Figure 4-1 illustrates that Sample 2 reached the failure pressure of 119% SMYS in 4.53 seconds. The seam (0°) and base pipe (90°) hoop strain gages in

Figure 4-1: Pressure vs. elapsed time for surge test of Sample 2 – 50% WT notch.

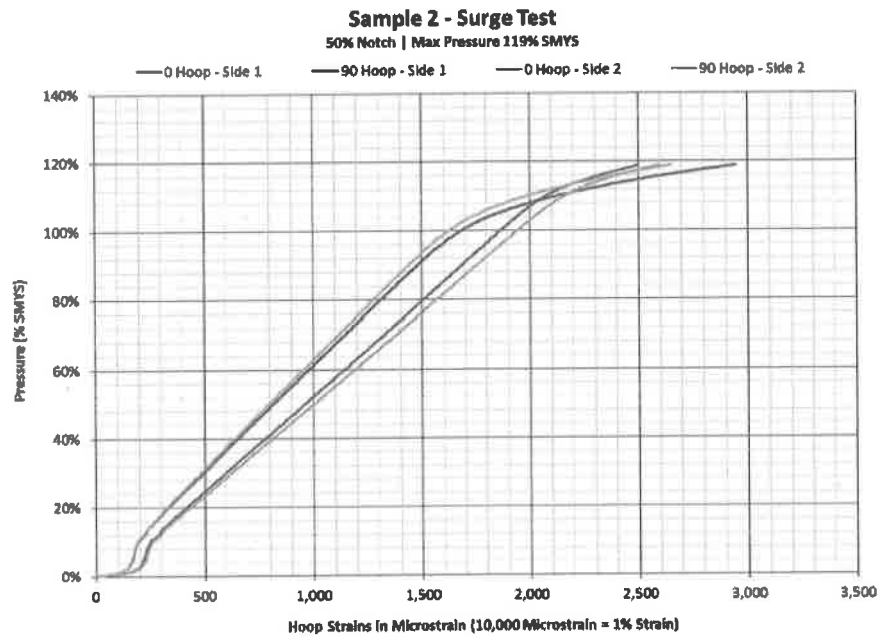
Figure 4-2 recorded mostly linear behavior until approximately 106% SMYS. There was a clear difference between the seam weld and base pipe strain response, which is expected due to the properties of the seam weld.

Figure 4-2: Pressure vs. hoop strains for surge test of Sample 2 – 50% WT notch.

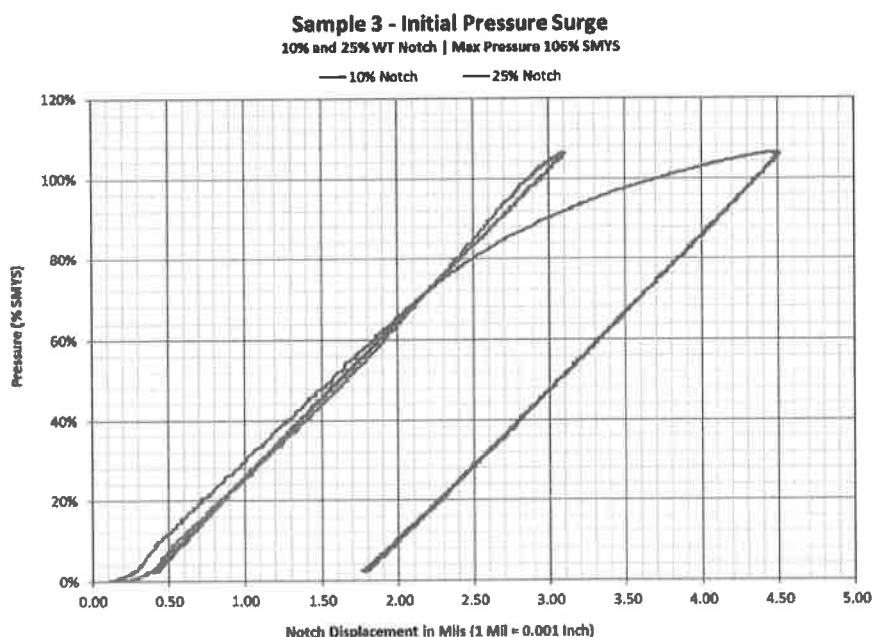
The 10% and 25% WT notches in Sample 3 were subjected to an initial pressure surge followed by 220 simulated pressure cycles. The purpose of the initial surge was to show that 25% and 10% WT defects could survive at 106% SMYS. The total time required for the surge to occur was 5.5 seconds. The seam and base pipe strains from the surge indicated that the seam behaves linear-elastically while the base pipe experiences a small amount of plastic strain. This is to be expected since the surge is over 100% SMYS and the seam has higher yield/tensile properties than the base pipe. The notch displacement measured by the clip gage in Figure 4-3 indicated the 10% notch experienced no change from the surge while the 25% notch experiences approximately 1.75 mils of displacement. Later samples indicated this notch displacement continued to increase with subsequent surges, but this portion of the test program only included one (1) surge.

Figure 4-3: Pressure vs notch displacement in mils (1 mil = 0.001 inch) for surge test of Sample 3 – 10% and 25% WT notch.

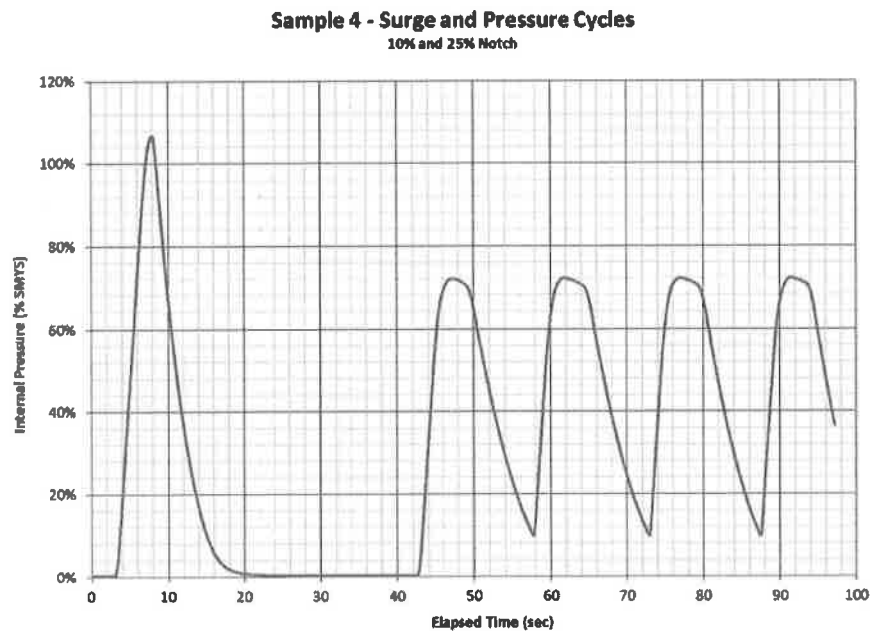
Figure 4-4 below displays the internal pressure vs. elapsed time for the first operational year (1 surge and 44 cycles at 10% to 72% SMYS) which is representative of the data taken for the other cycle/surge combinations.

Figure 4-4: Internal pressure vs. elapsed time for representative operational year of the cycle-surge fatigue test for Sample 4.

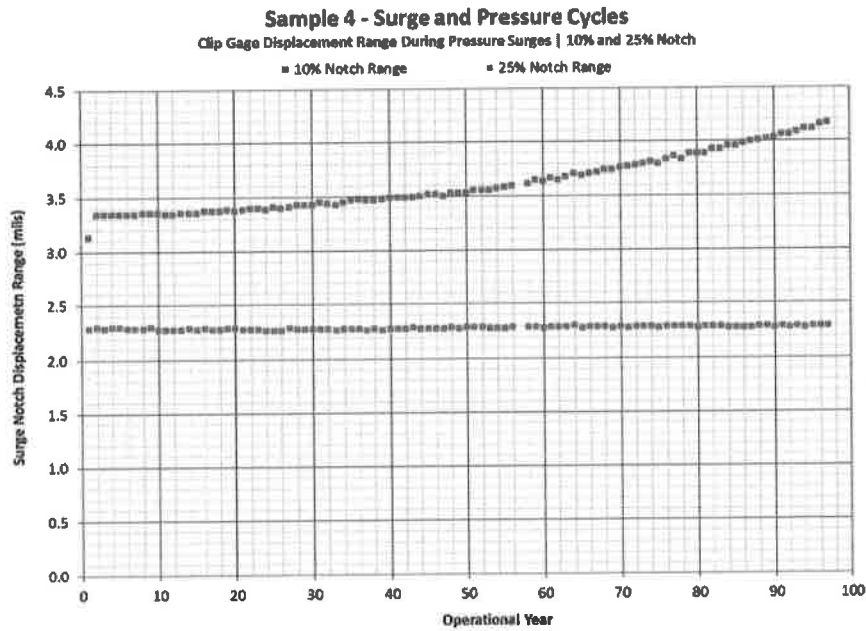
Figure 4-5 displays the notch displacement range for all 97 pressure surges in mils (1,000 mils = 1-inch). Note that the displacement range is the difference between the max and min displacement during the pressure surge, and the notch opening displacement is the opening of the notch (not measuring crack growth into the wall thickness). The 10% notch saw no increase in displacement range for all 97 surges. The 25% notch though experienced a steady increase in notch opening displacement after the initial 20 simulated years. The initial and final displacement range for the 25% notch was 3.13 mils (0.00313-inch) and 4.17 mils (0.00417-inch) respectively. Due to a technical issue with the data acquisition, data was not recorded for cycle 57.

Figure 4-5: Notch displacement range (mils) vs operational year for the 97 pressure surges of Sample 4 (10% and 25% Notches).

Figure 4-5 where the notch displacement range grows with each surge. This figure also indicates that the 10% notch did not experience any growth due to the constant displacement range. The Fractographic image seen in Figure 5-5 also has a clearly visible band of fatigue growth for the 25% notch. This growth is mostly likely due to the pressure surges and not cycles. This is supported by the 25% notch in Sample 3 (5-year representative inspection interval) not experiencing any fatigue growth during five simulated years of continuous cycling with no intermediate pressure surges. Also, the high magnitude pressure surge would blunt the crack tip by creating a localized area of plasticity at the tip. The initial 25% notch and subsequent crack growth from 97 years of equivalent cycles and surges did not greatly reduce the pipe strength though. The pipe burst at a pressure equivalent to 132% SMYS.

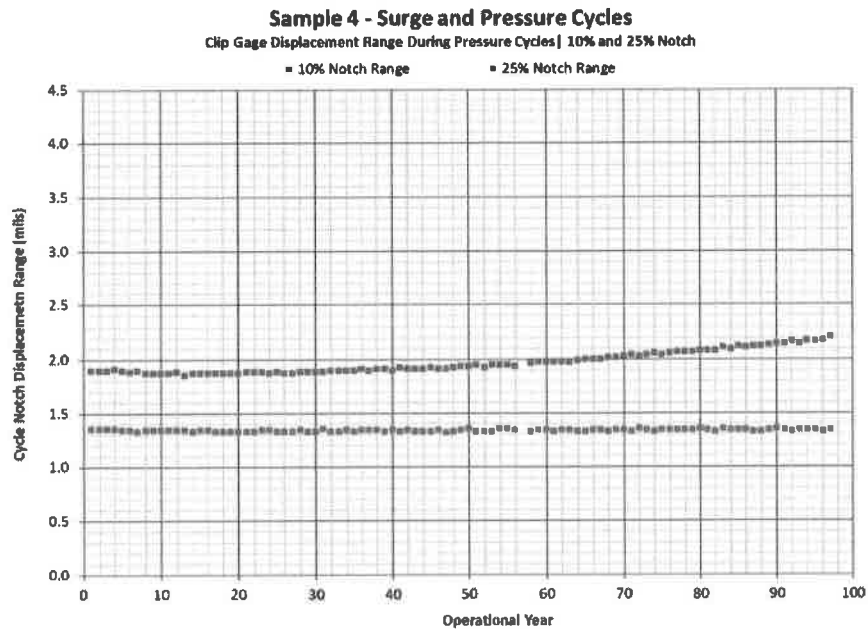
Figure 4-6 displays the same notch opening displacement for the pressure cycles over the simulated 97 year operational period. In this figure, the data represents the maximum notch displacement range over the recorded cycles in each operational period. In other words, the 19 to 44 equivalent cycles during each operational period were compressed to one maximum displacement range. This was done because the notch displacements during the cycling only portion of the fatigue test showed no signs of increasing. The steady increase in the 25% notch displacement range in Figure 4-6 is due to growth achieved during the pressure surges, and not from any growth during the cycles.

Figure 4-6: Maximum notch displacement range (mils) for the pressure cycles of each operational year of Sample 4 (10% and 25% Notches).

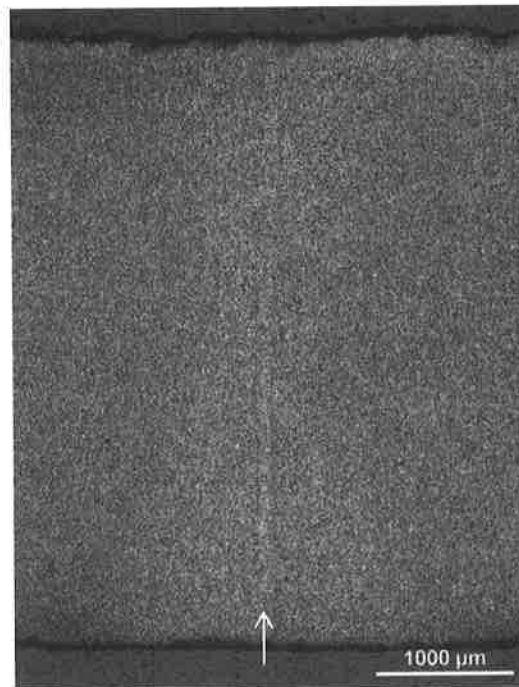
SES prepared a metallurgical cross section of the long seam weld from a pipe section not used in testing. Based on the microstructure of the body of the pipe, heat-affected zone, and bond line of the weld, it appeared that the pipe examined was likely produced using the high frequency ERW process. The arrow in Figure 5-9 represents the approximate bond line.

Figure 5-9: Photomicrograph of ERW long seam weld present in a fabrication drop from P66 Sample 5. White arrow indicates ERW bondline. Etchant is 2% Nital, original magnification is 25x.
